TREATMENT REPORT: PROMONTORY TRESTLE STABILIZATION AT GOLDEN SPIKE NATIONAL HISTORIC SITE

PREPARED FOR THE NATIONAL PARK SERVICE

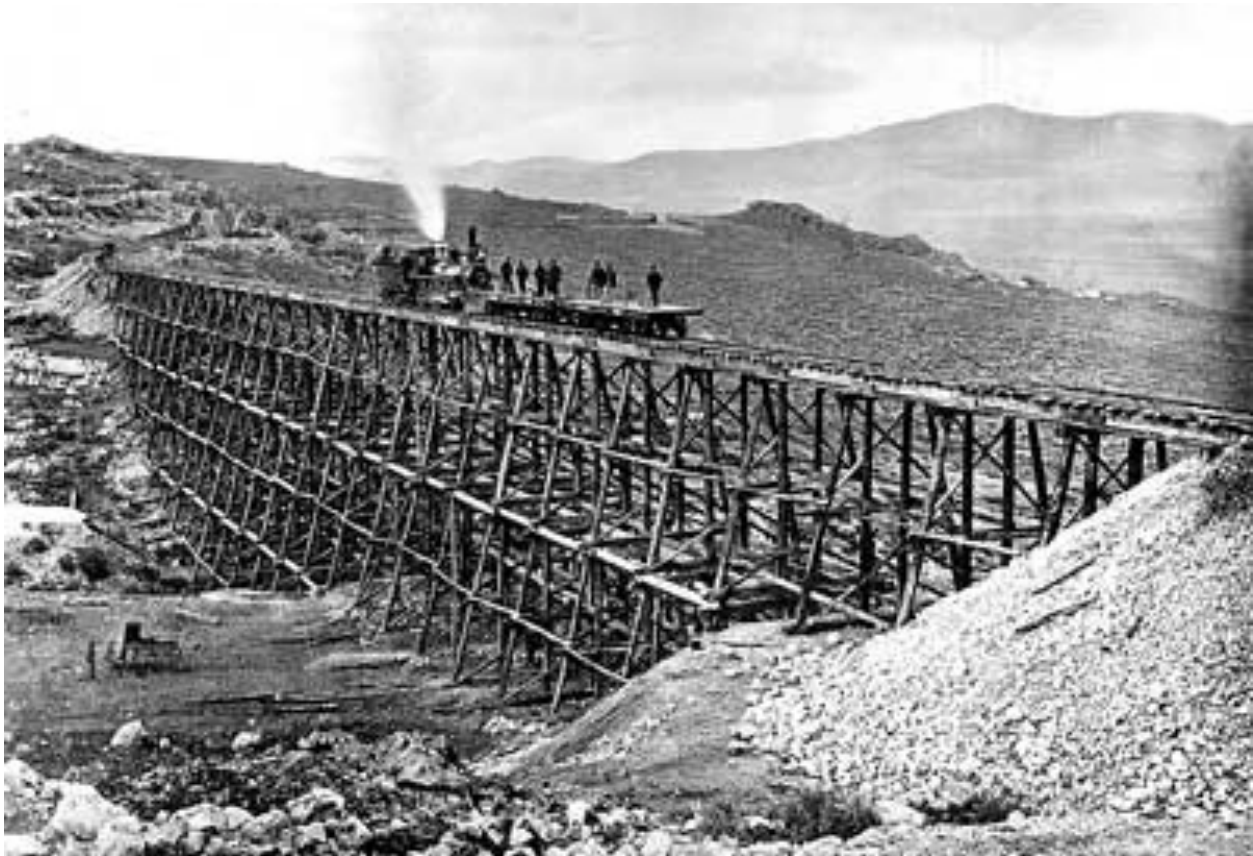
Figure 1: Wood proved to be an inexpensive way for rail companies to bridge obstacles during the construction of the transcontinental rail line. While many of the trestles erected during this time were small pile structures like the Promontory Trestles of this project, others were far larger and more complex, like the Big Trestle that once stood on the Union Pacific Grade a few miles southwest of the project site. Photo courtesy Utah State History, <http://history.utah.gov/experience_history/visit_historic_places/golden-spike.html>.

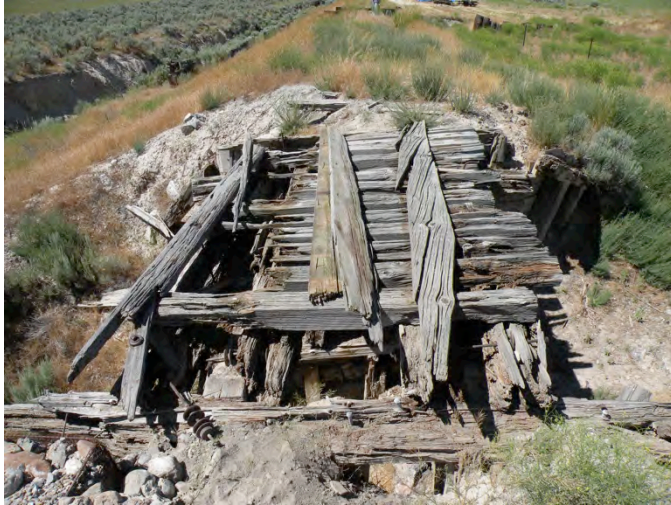
Figure 2: Many of the members of Trestle #1 were badly deteriorated.

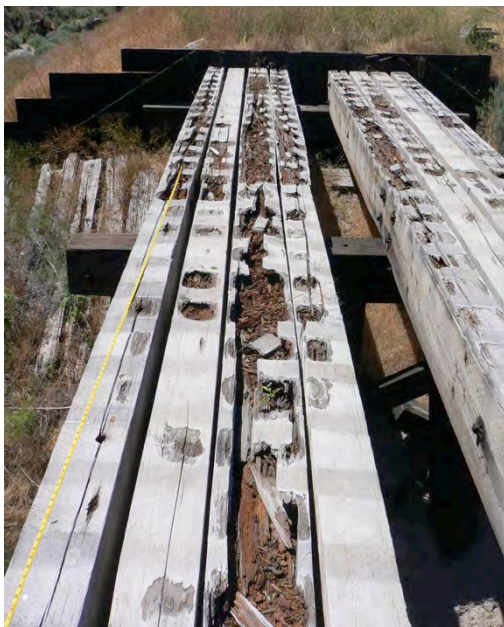
Figure 3: The stringers of Trestle #2 had extensive decay pockets along their length.

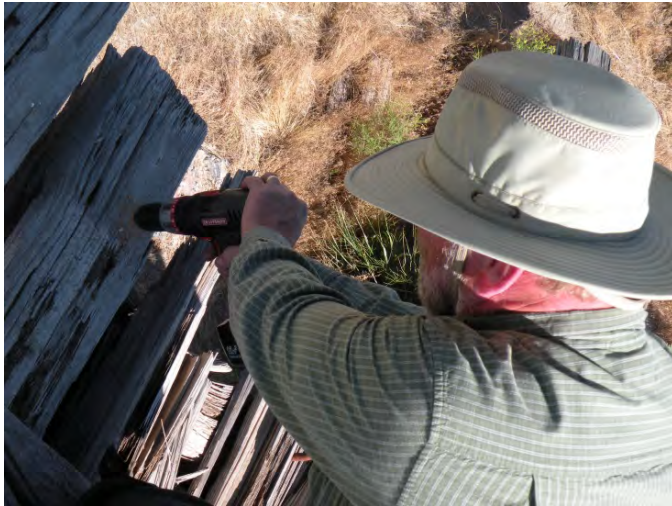
Figure 4: Removing a sample from a tie for species identification.

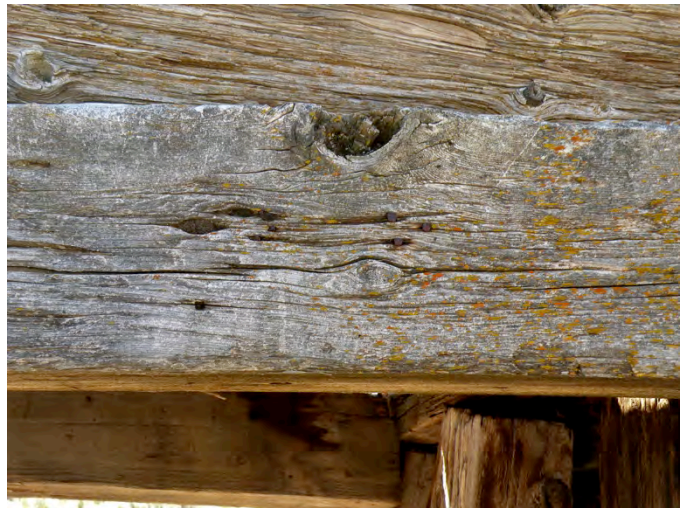
Figure 5: Example of an edge knot on the north strut of Trestle #1.

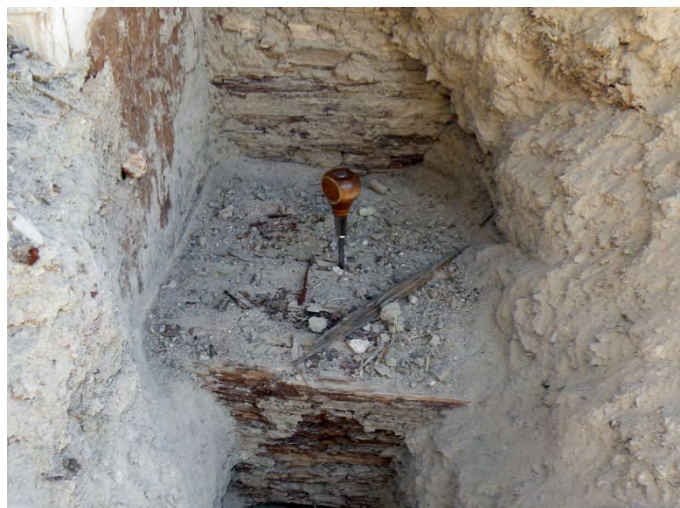
Figure 6: An awl can easily be inserted into the mudsill, east bent, Trestle #1.

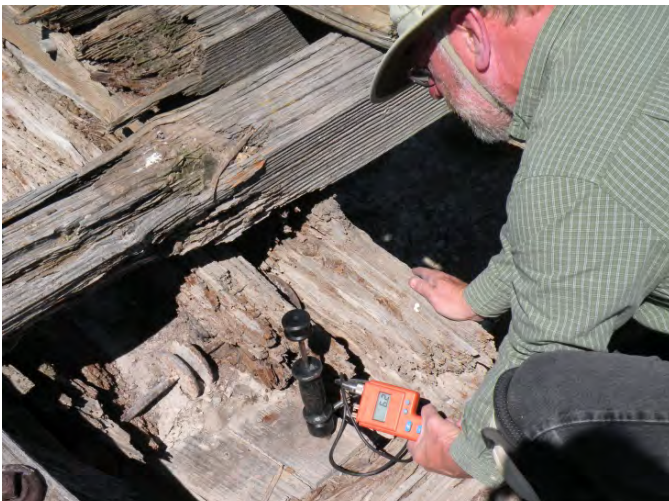
Figure 7: Determining the moisture content of a top strut, Trestle #1.

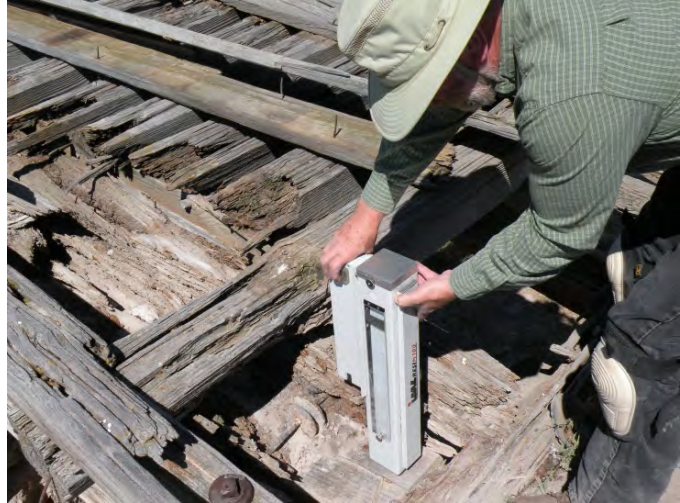
Figure 8: Using the resistance drill in a top strut, Trestle #1.

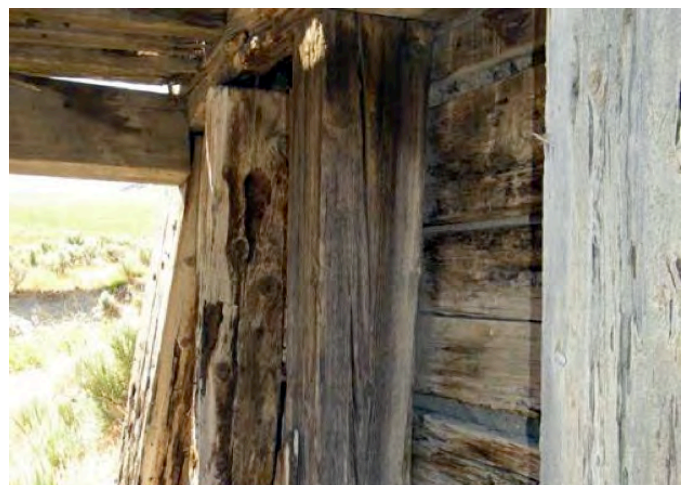
Figure 9: West bent of Trestle #1 showing slope of grain (W2, center) and large knots (W3, adjacent, left).

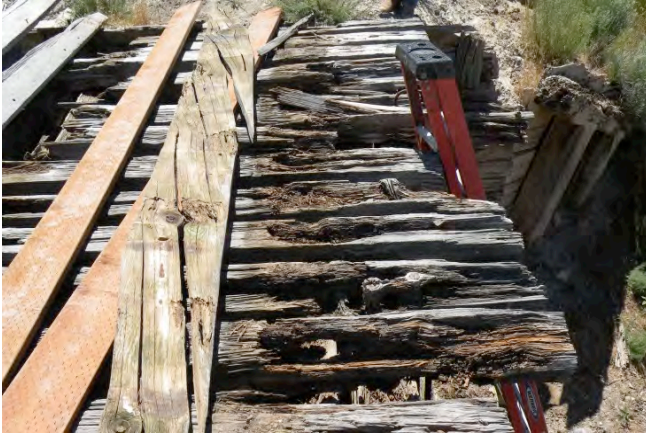
Figure 11: Deteriorated ties on Trestle #1.

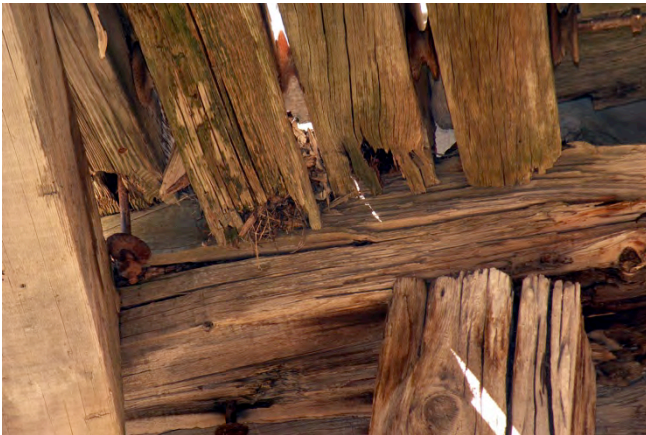
Figure 12: Deterioration at the bearing areas of the stringers.

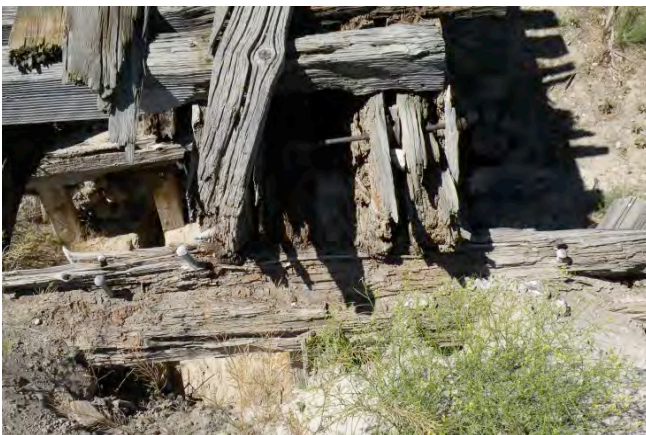
Figure 13: East pile cap (foreground) with severe deterioration.

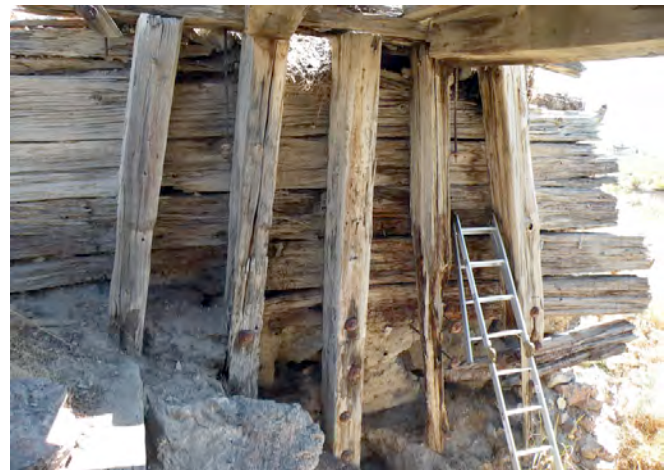
Figure 14: East bent piles with severe deterioration.

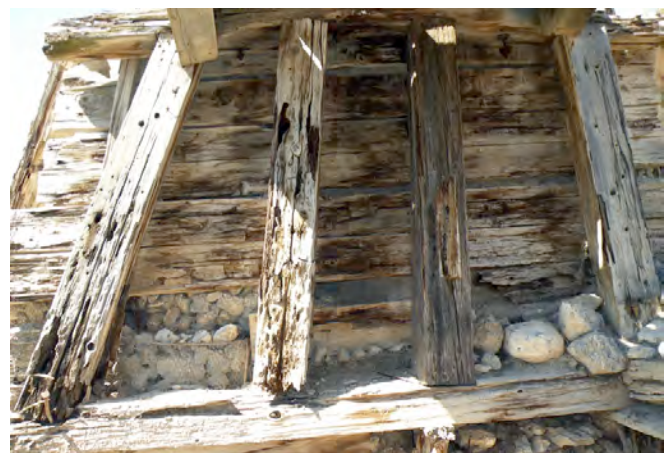
Figure 15: West bent piles with visible deterioration.

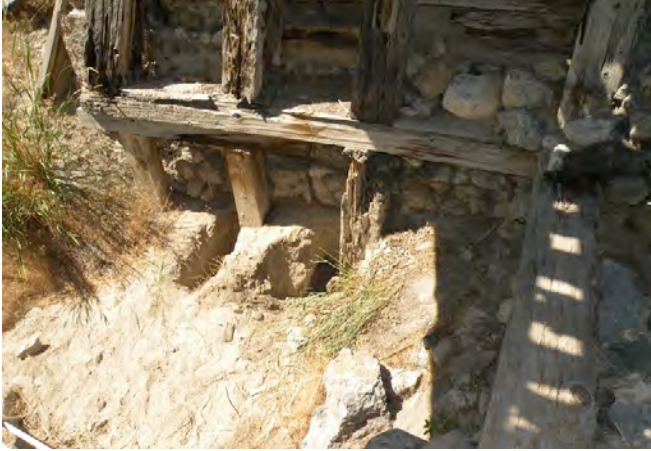
Figure 16: West bent intermediary sill with some decay. The two supporting piers to the left were replacements, and the older piers to the right were largely lost to decay.

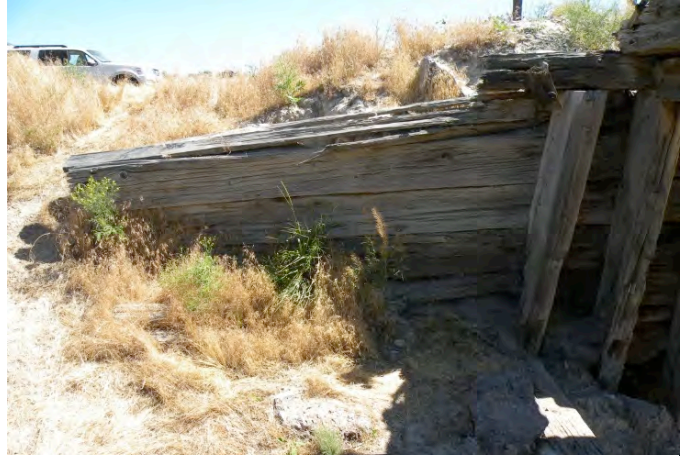
Figure 17: Northeast wing wall with surface and end deterioration.

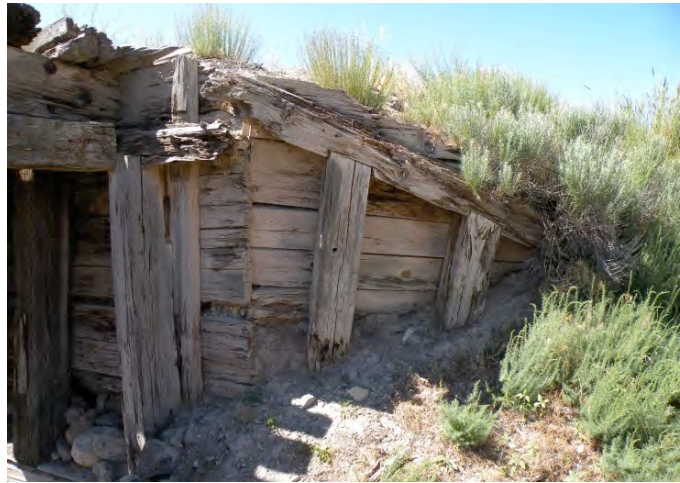
Figure 18: The northwest wing wall.

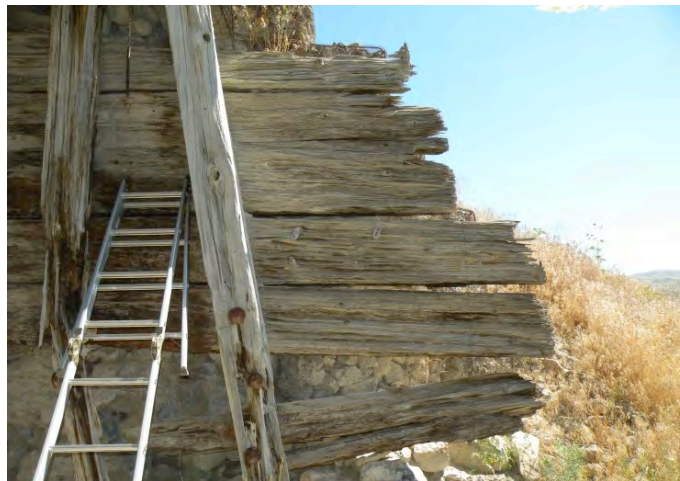
Figure 19: Southeast wing wall.

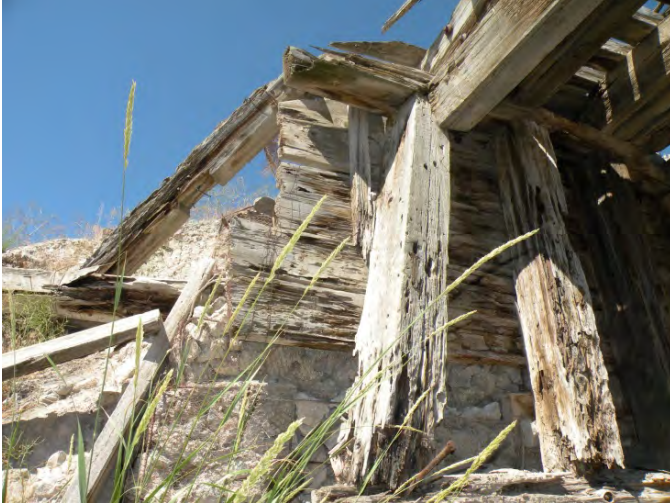
Figure 20: The southwest wing wall.

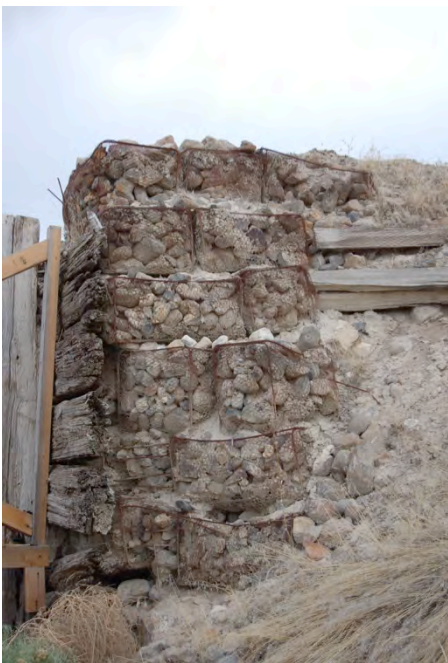
Figure 21: Gabions at the east bulkhead.

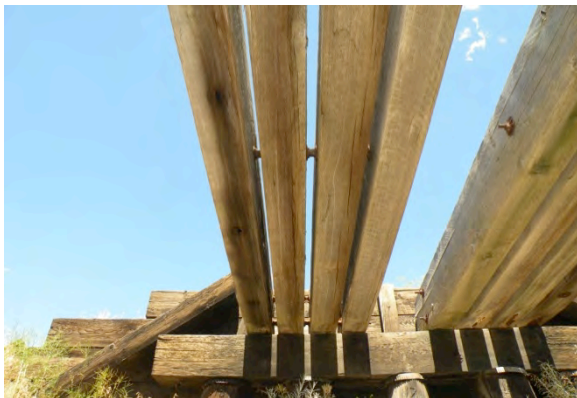
Figure 23: Trestle 2 stringers appeared sound when viewed from below, but all had internal deterioration.

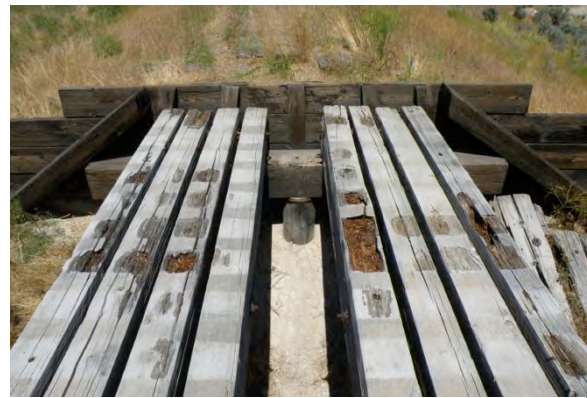
Figure 22: Trestle #2 stringers showing pockets of deterioration on the top faces.

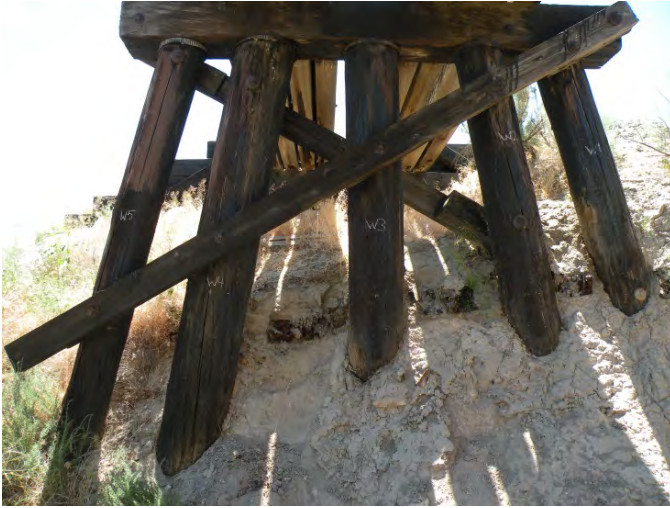
Figure 24: Creosote-treated west bent piles, Trestle #2.

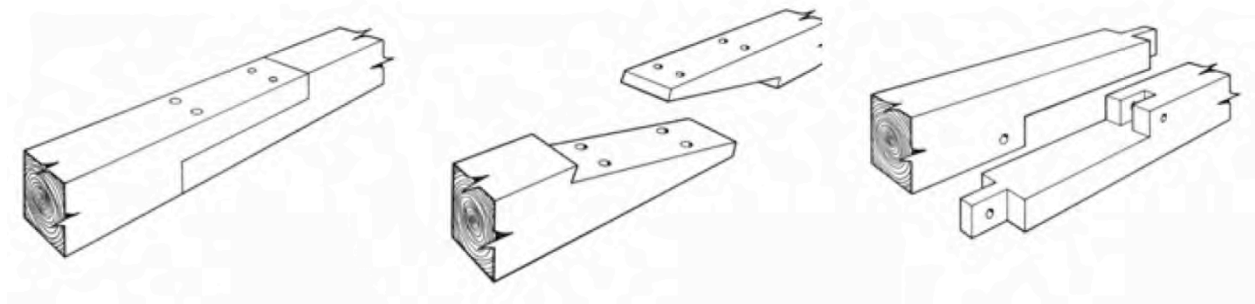
Figure 25: Three forms of a scarfed splice: halved, splayed, and bridled. Hirst, et al. “The Structural Performance of Traditional Oak Tension and Scarf Joints.” 2008.

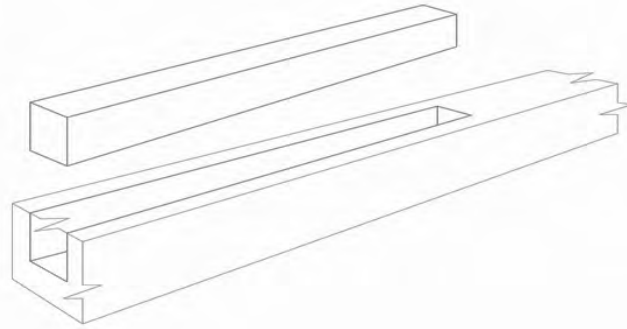
Figure 26: Typical dutchman repair. The decayed portion of the existing member is removed, and a new piece is cut to fit tightly into the void. The repair may be secured with mechanical fasteners and/or an adhesive.

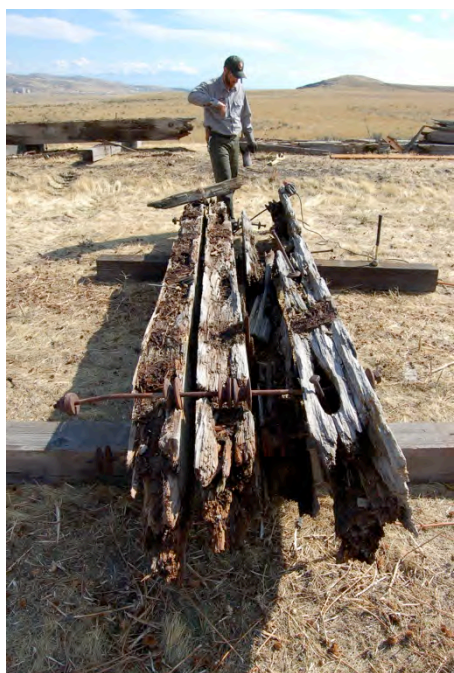
Figure 27: One of the original stringer assemblies removed from Trestle #1. Portions of two of the girders were salvaged and repaired for reinstallation.

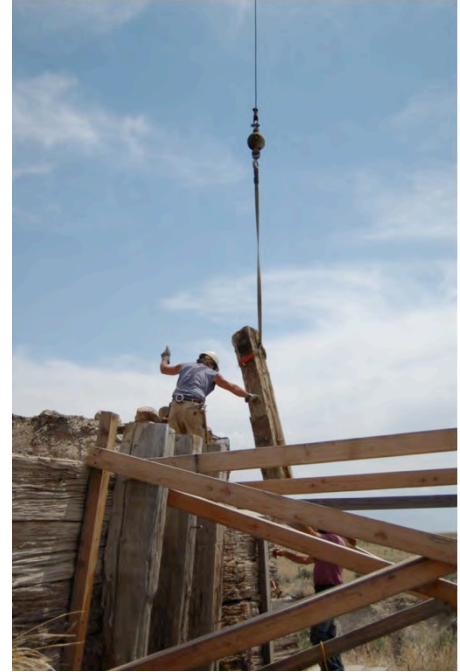
Figure 28: A decayed pile is removed from the east bent.

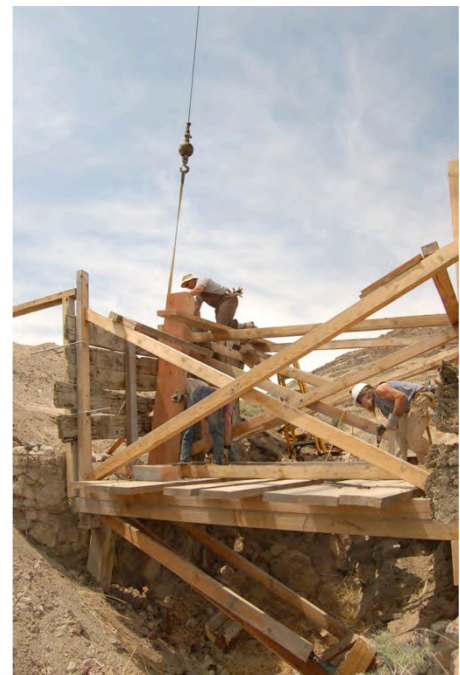
Figure 29: A new pile is lowered into the west bent.

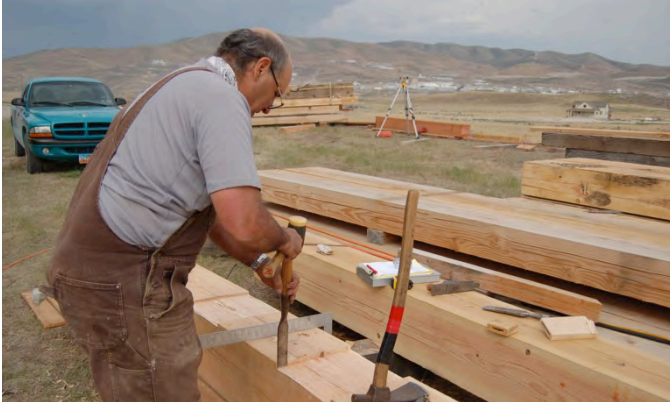
Figure 30: Squaring a mortise in a replacement pile cap with a chisel. The joints are laid out to fit the tops of the piles.

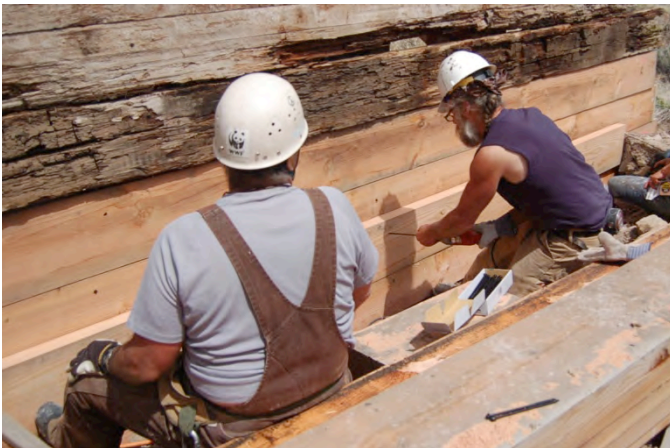
Figure 31: Installing the second layer of planking at the west bulkhead.

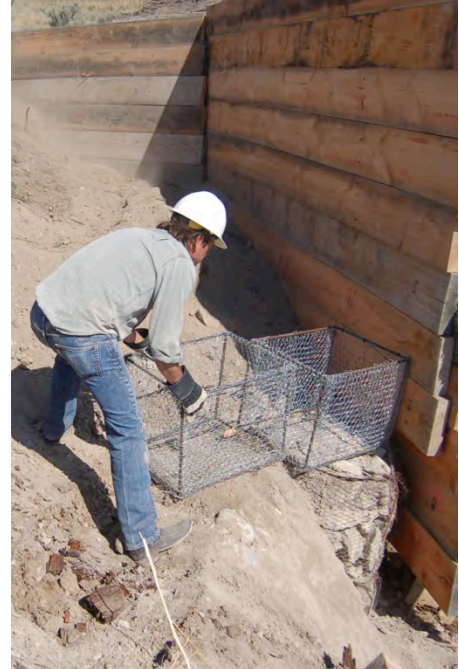
Figure 32: Setting new gabions at the south end of the west bulkhead.

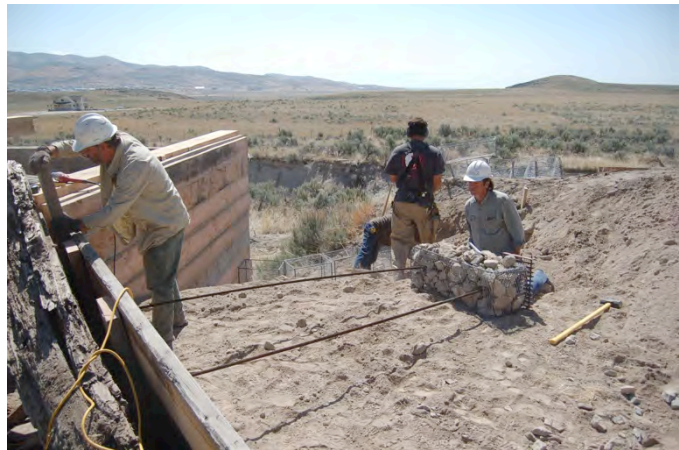
Figure 33: Tie-backs installed at the northwest wing wall.

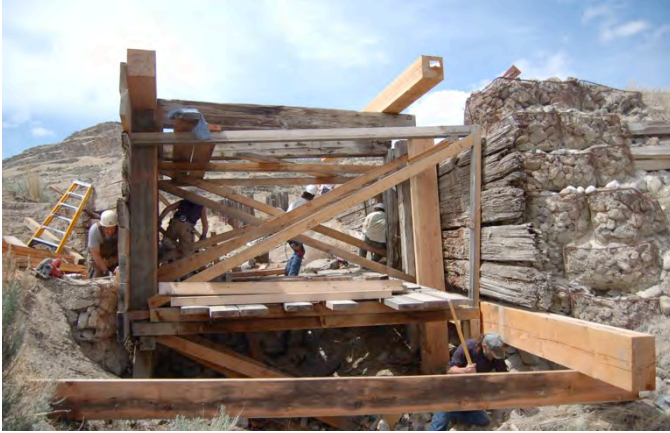
Figure 34: One of the lower planks on the east bulkhead was replaced to provide added support to prevent additional erosion of the fill material behind the bulkhead. The plank was later cut flush with the existing bulkhead planking.

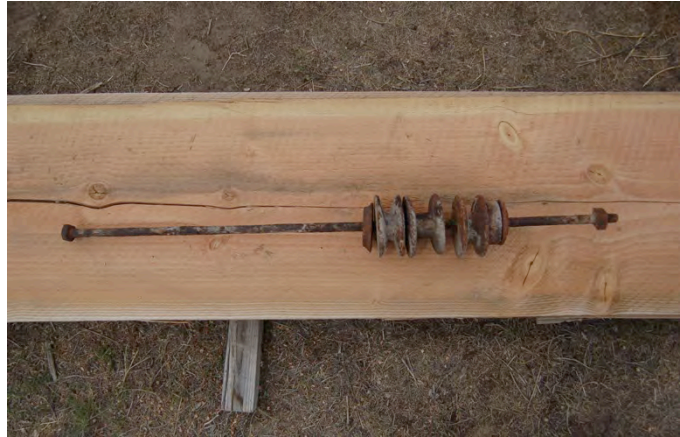
Figure 35: Hardware salvaged from an original stringer assembly.

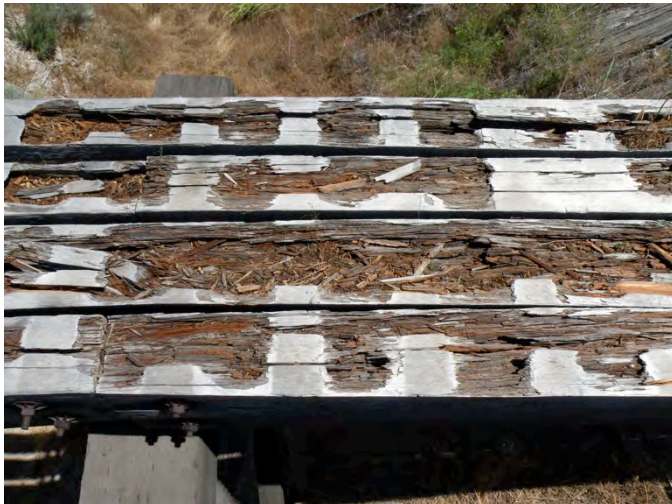
Figure 36: Extensive decay was found along the stringers of Trestle #2.

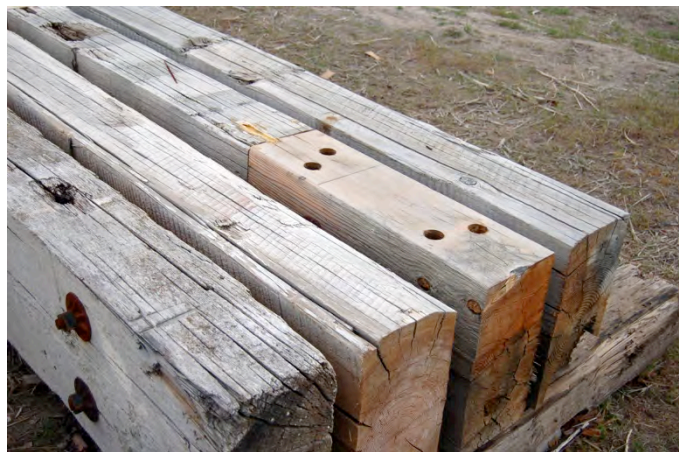
Figure 38: A dutchman repair on the third stringer from the left, Trestle #2.

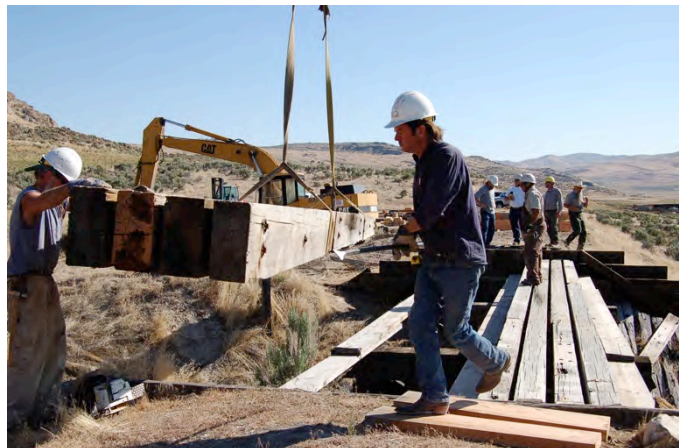
Figure 37: Lowering the second stringer assembly onto the trestle.

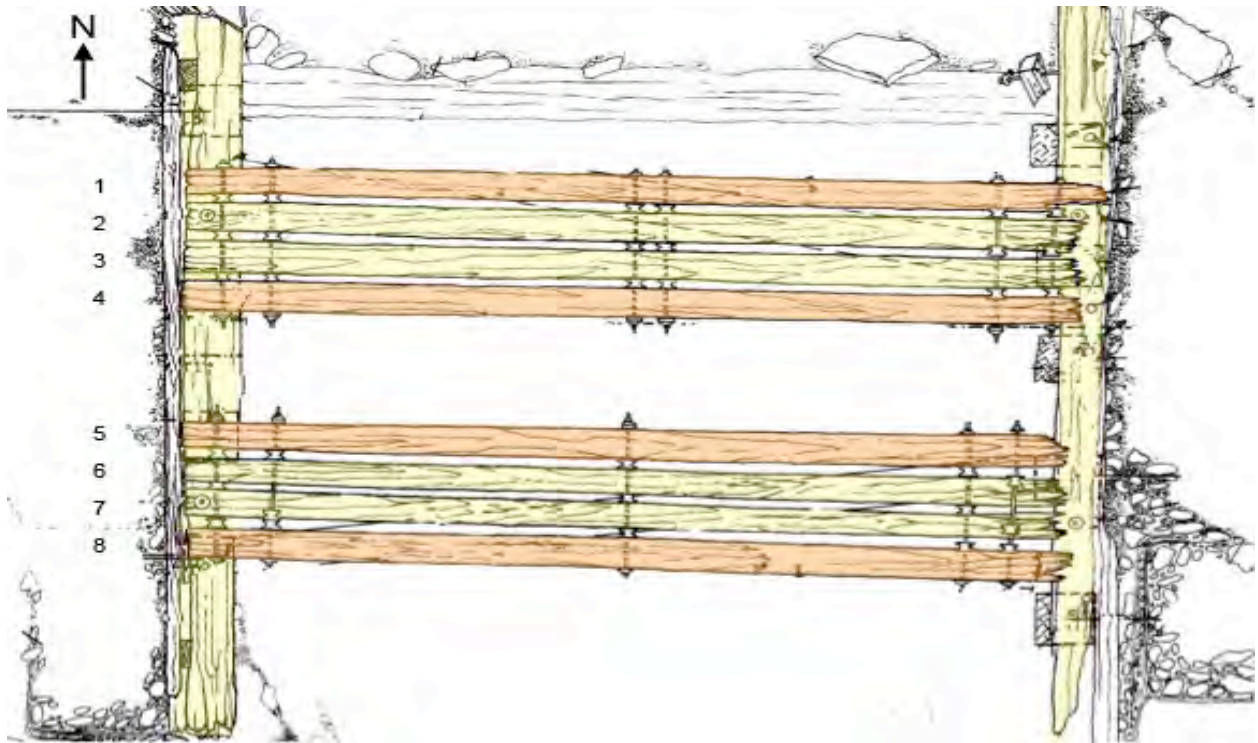
Figure 45: Trestle #1, plan. Members shaded in yellow were replaced in-kind in entirety. Members shaded in orange were repaired. See Figures 41 - 44 in this appendix for details of repair conditions.

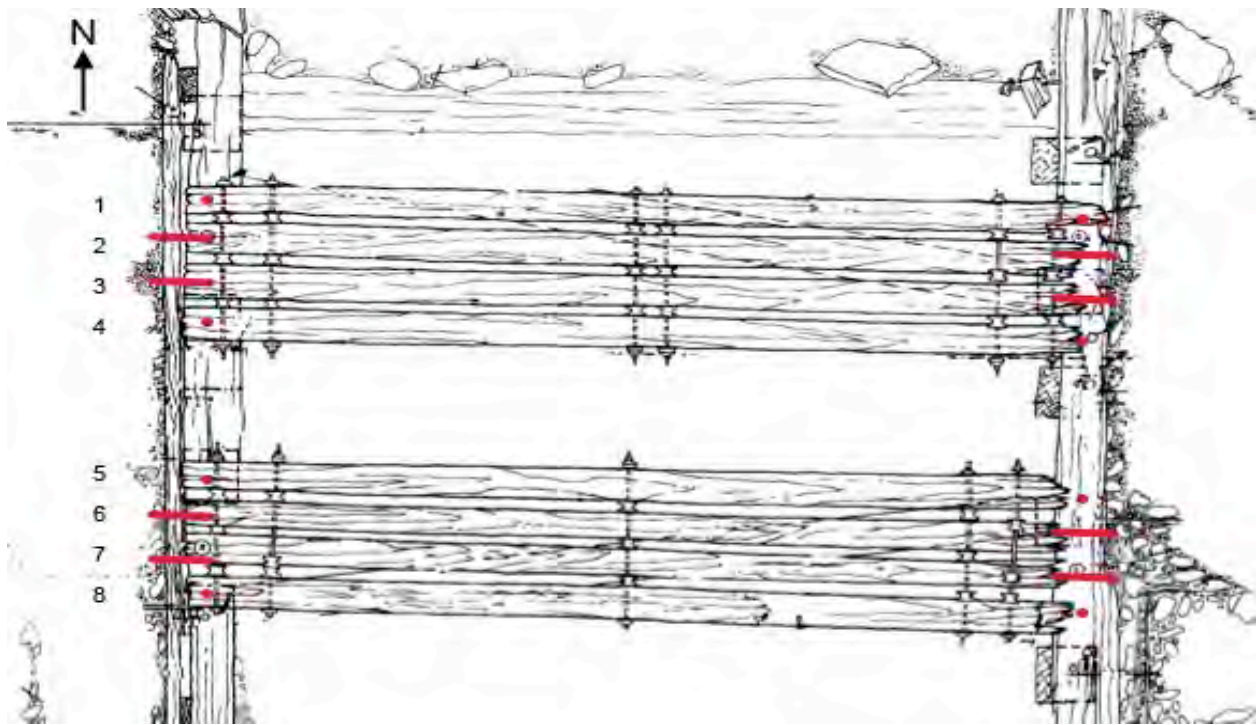
Figure 46: Trestle #1, plan. Approximate location of drift pins used to secure stringer assemblies indicated in red.

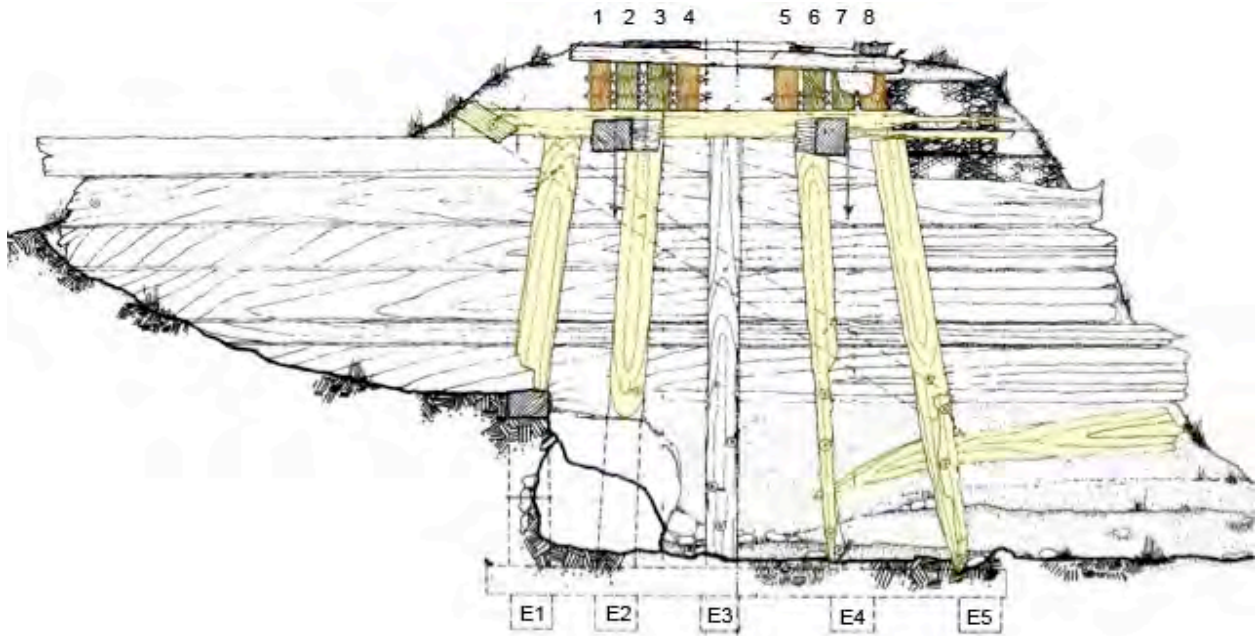
Figure 47: Trestle #1, east bent and bulkhead. Members shaded in yellow were replaced in entirety. Members shaded in orange were repaired. See Figures 42 - 45 in this appendix for details of repair conditions.

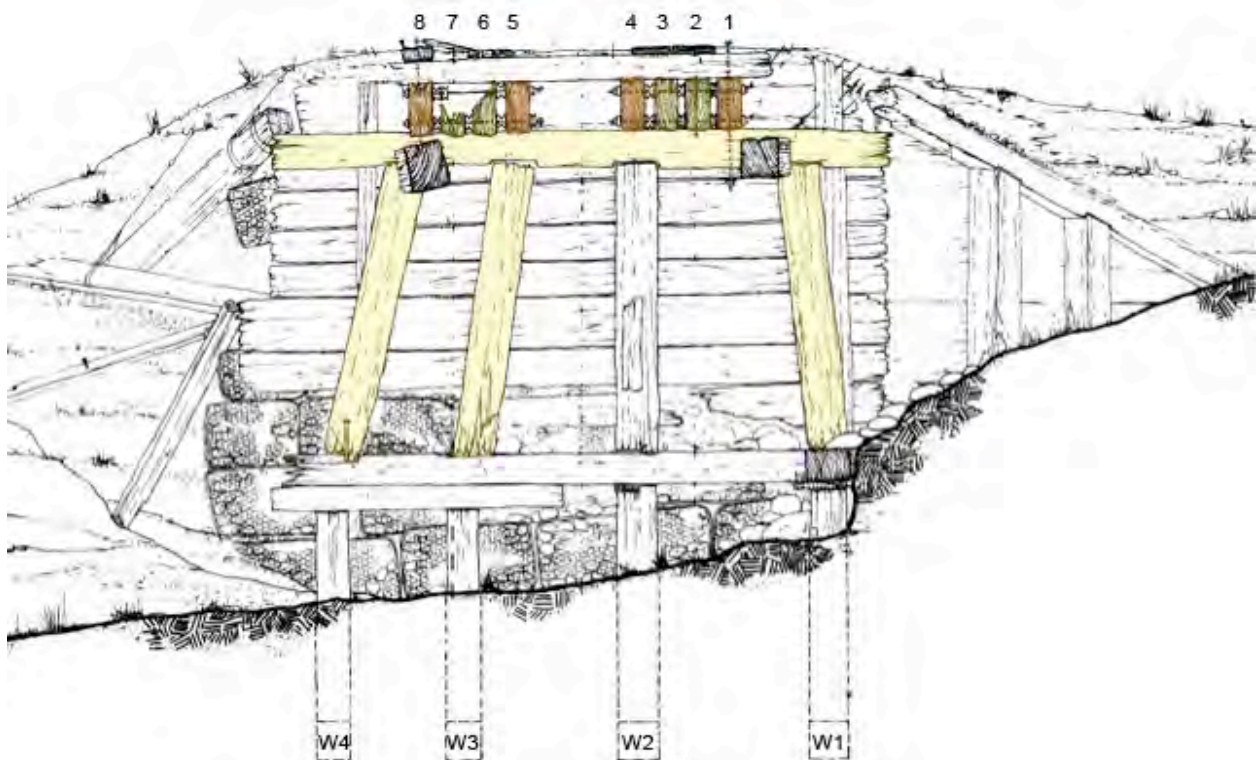
Figure 48: Trestle #1, west bent and bulkhead. Members shaded in yellow were replaced in-kind in entirety. Members shaded in orange were repaired. Much of the west bulkhead planking behind was also replaced in-kind. See Figures 42 - 45 in this appendix for details of repair conditions.

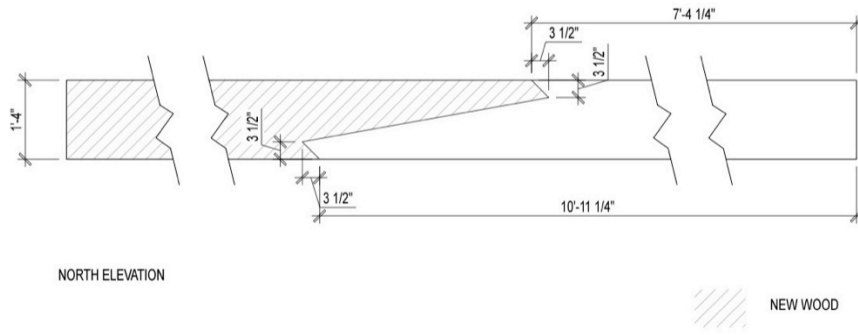
Figure 49: Repair for stringer at position 1, Trestle #1.

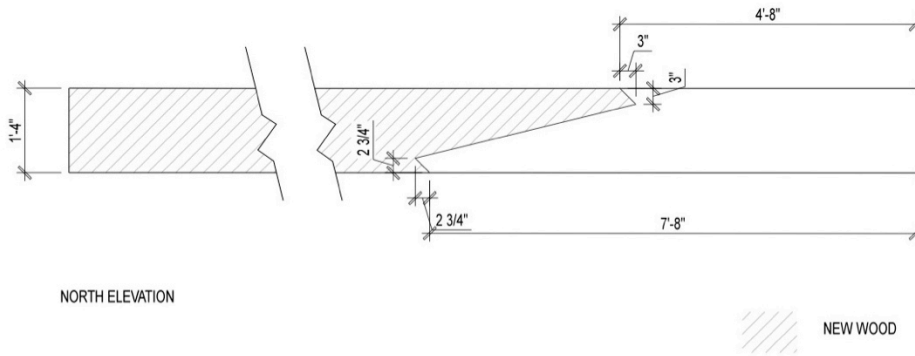
Figure 50: Repair for stringer at position 4, Trestle #1.

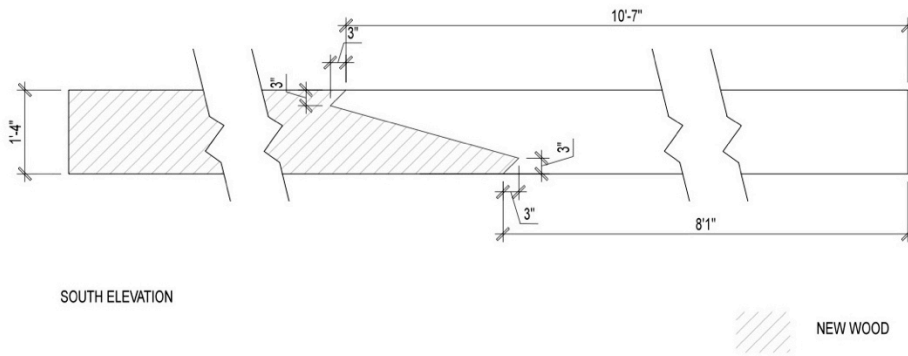
Figure 51: Repair for stringer at position 8, Trestle #1.

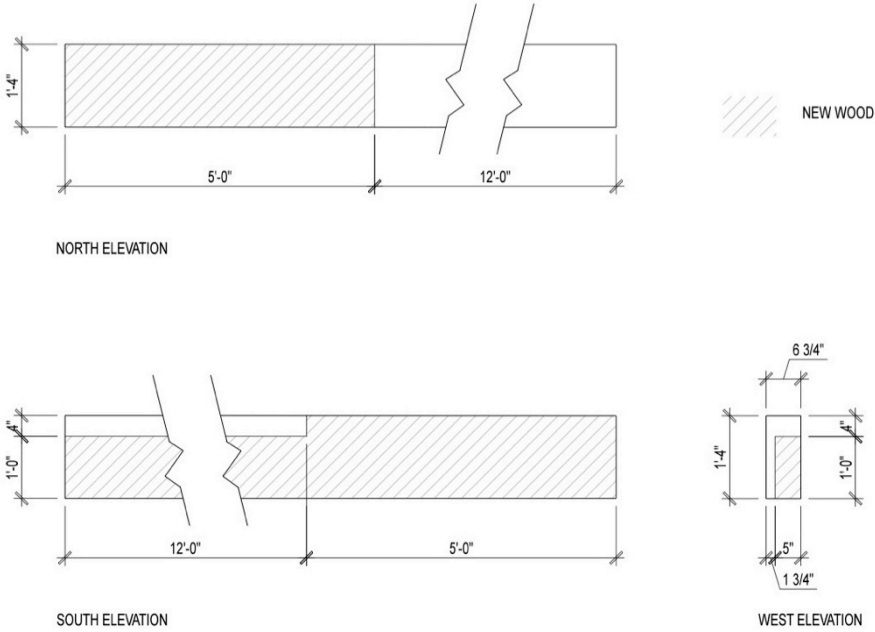
Figure 52: Repair for stringer at position 5, Trestle #1.

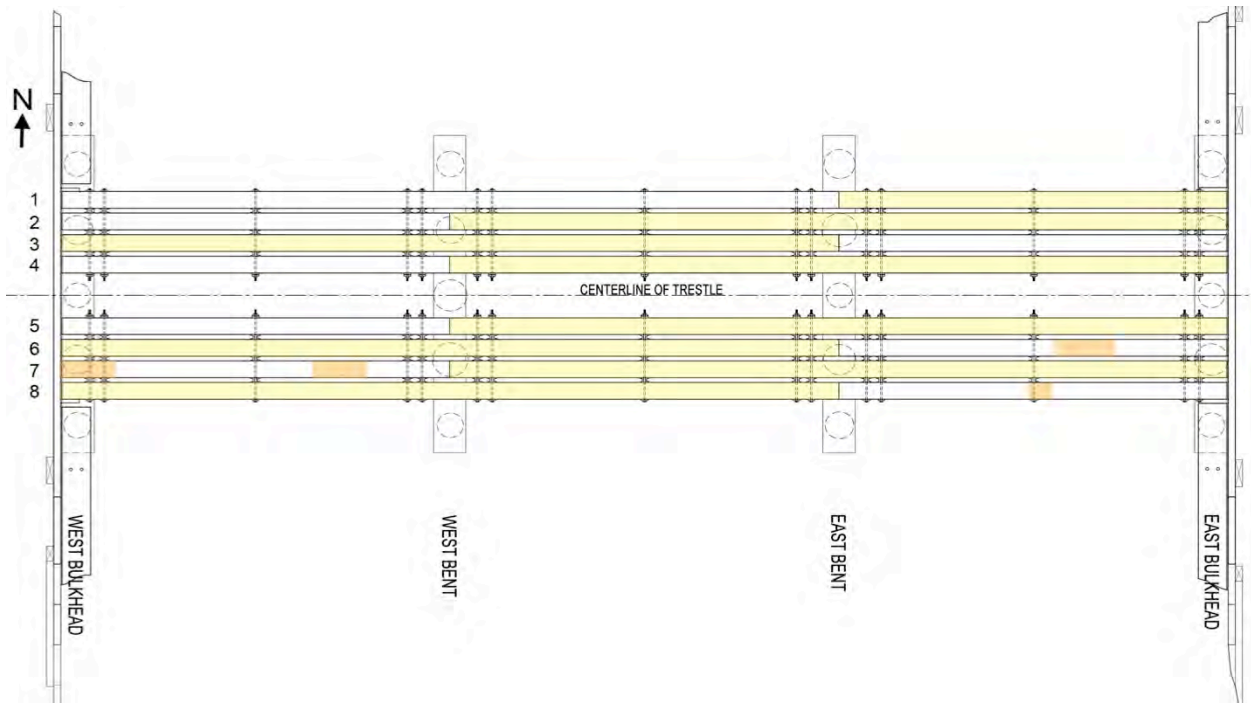
Figure 53: Trestle #2, plan. Members shaded in yellow were replaced in-kind in entirety. Areas shaded in orange are dutchman repairs.

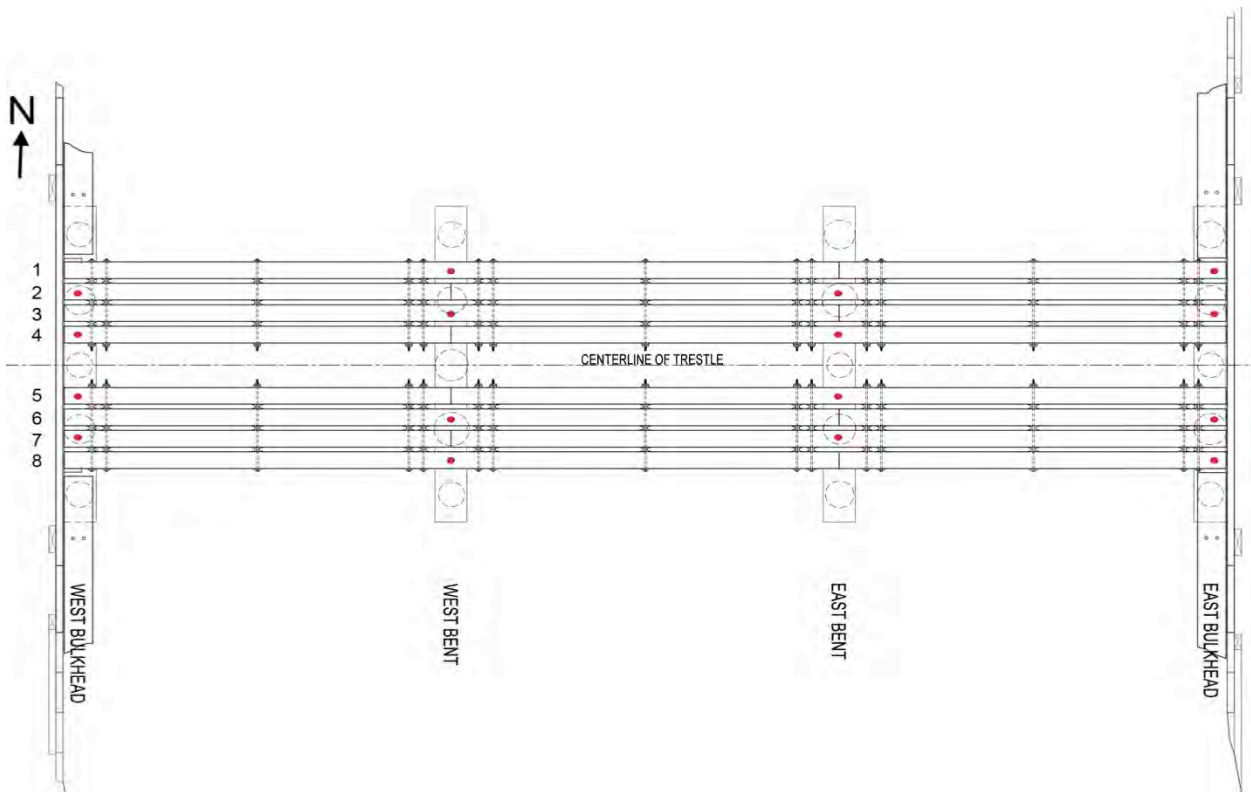
Figure 54: Trestle #2, plan. Approximate location of drift pins used to secure stringer assemblies indicated in red.

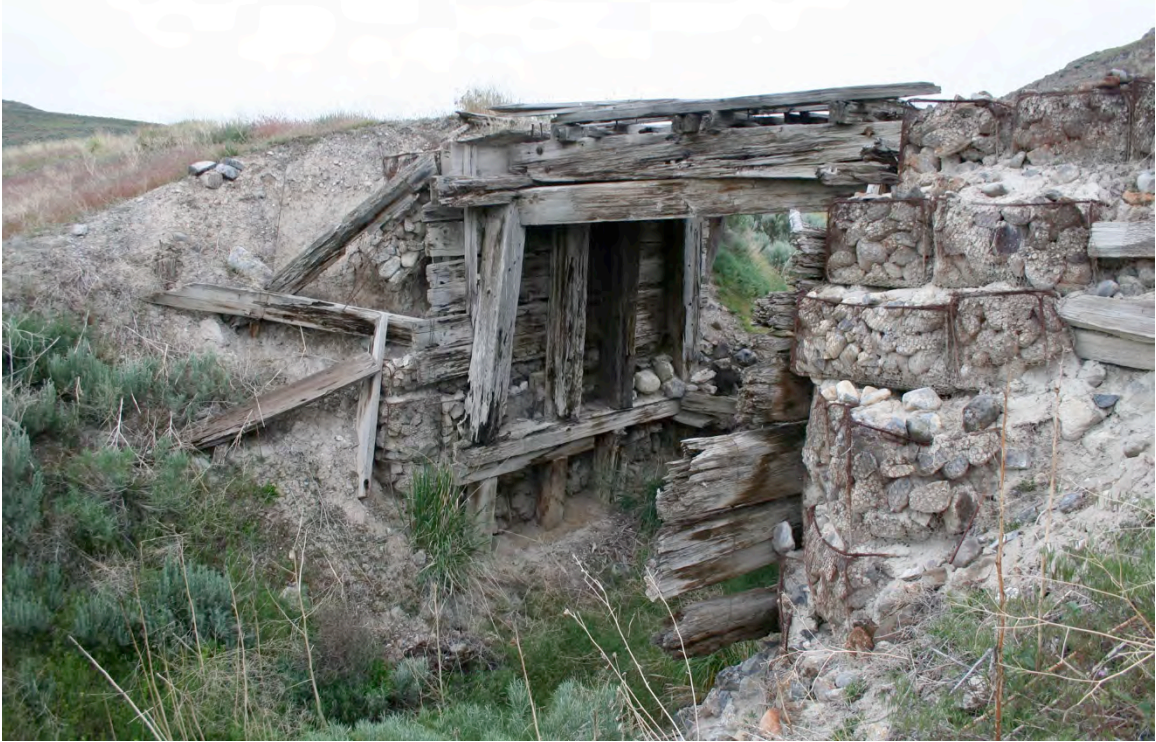
Figure 55: Trestle #1 before stabilization.

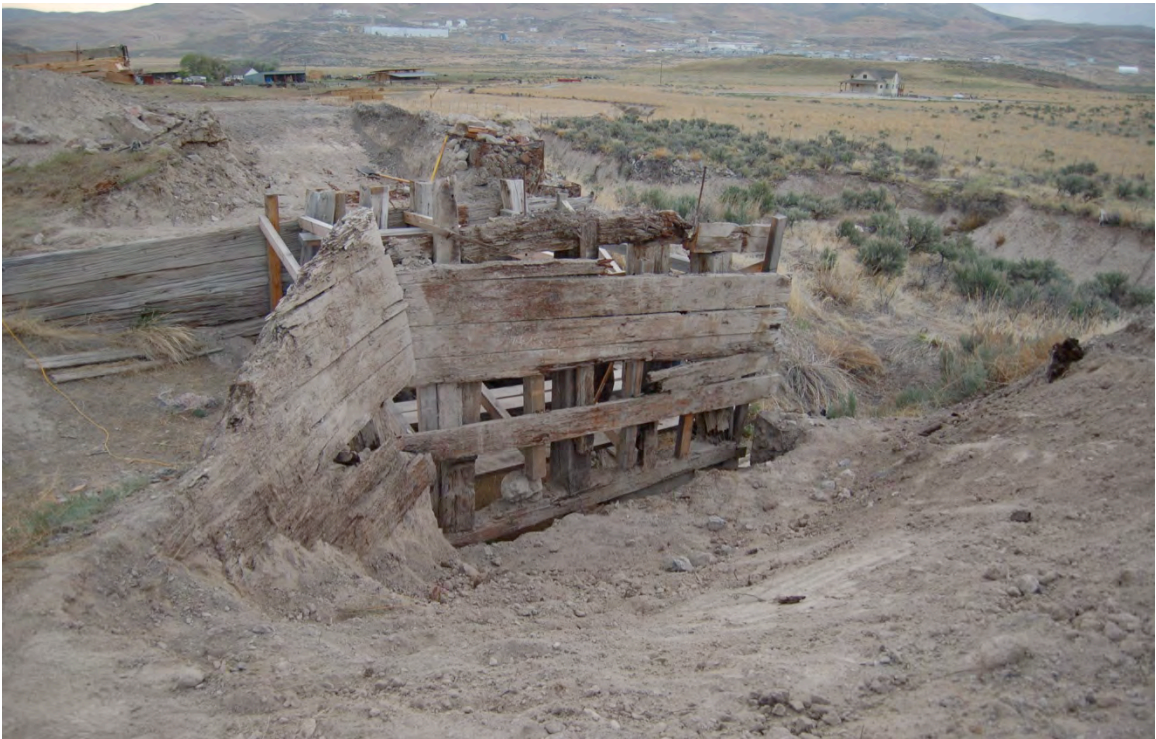
Figure 56: The west bulkhead after excavation. Note the extreme deterioration of the bulkhead planking.

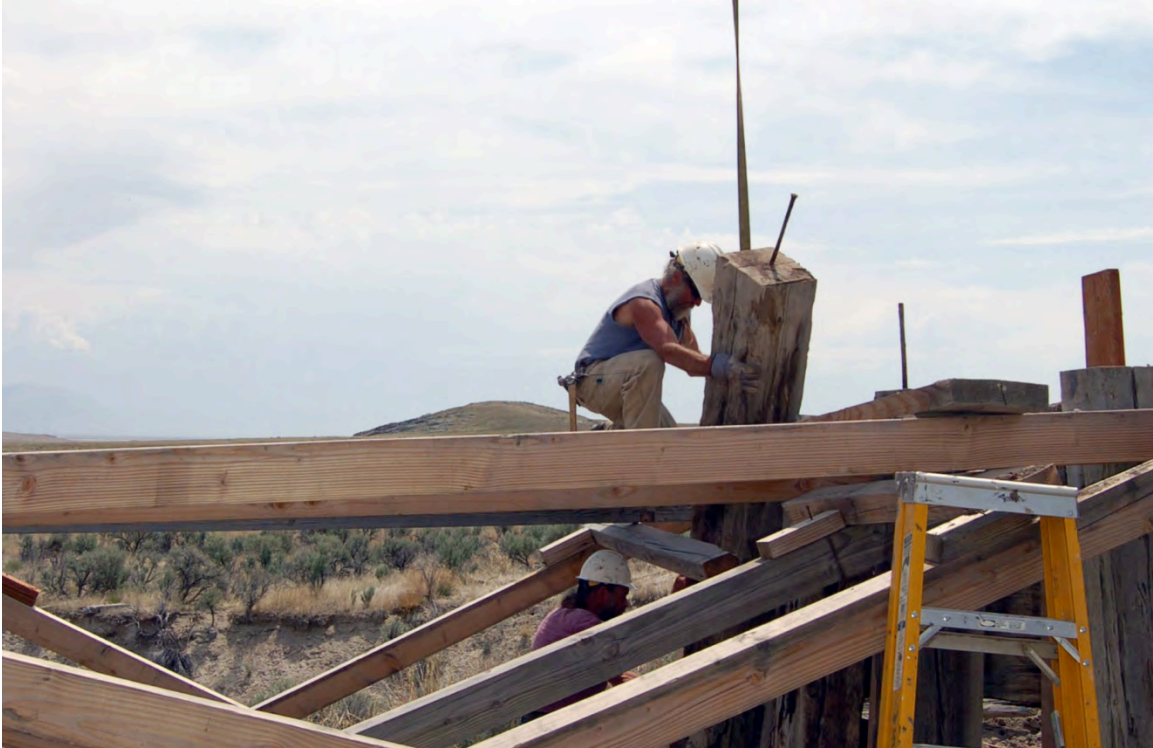
Figure 57: Removing an unsalvageable pile from the west bent.
