TREATMENT REPORT: PROMONTORY TRESTLE STABILIZATION AT GOLDEN SPIKE NATIONAL HISTORIC SITE

PREPARED FOR THE NATIONAL PARK SERVICE

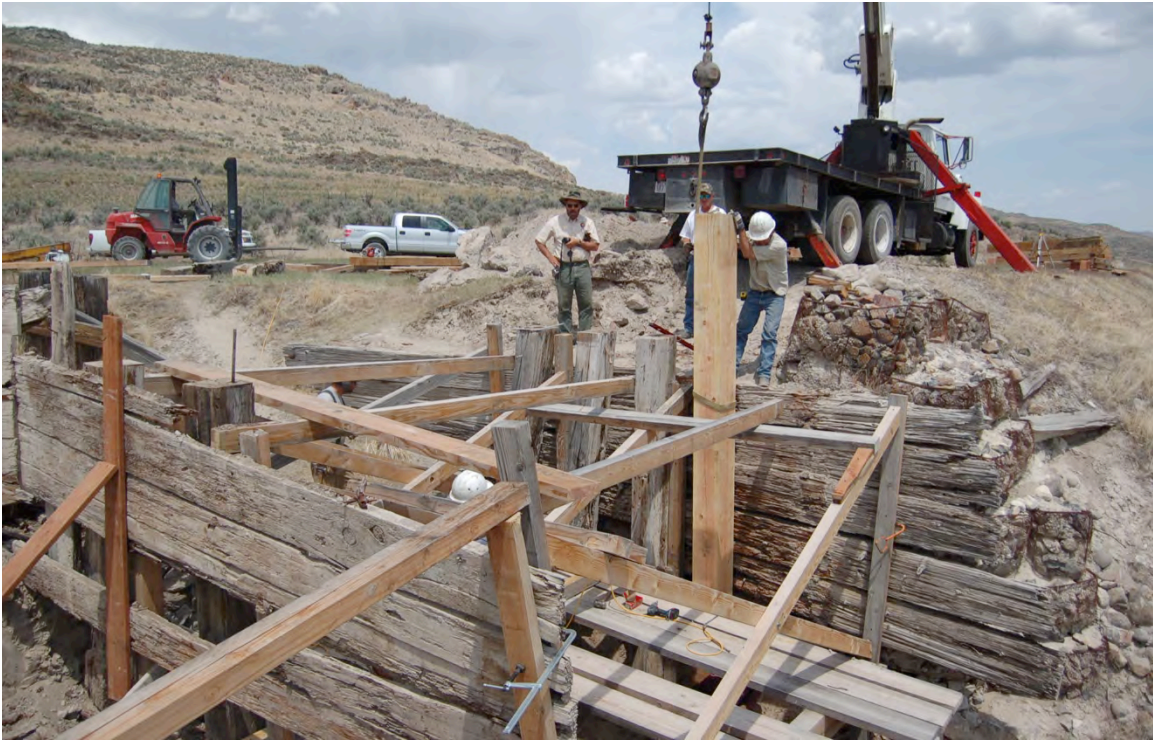
Figure 58: Lowering a replacement pile into position at the east bent.

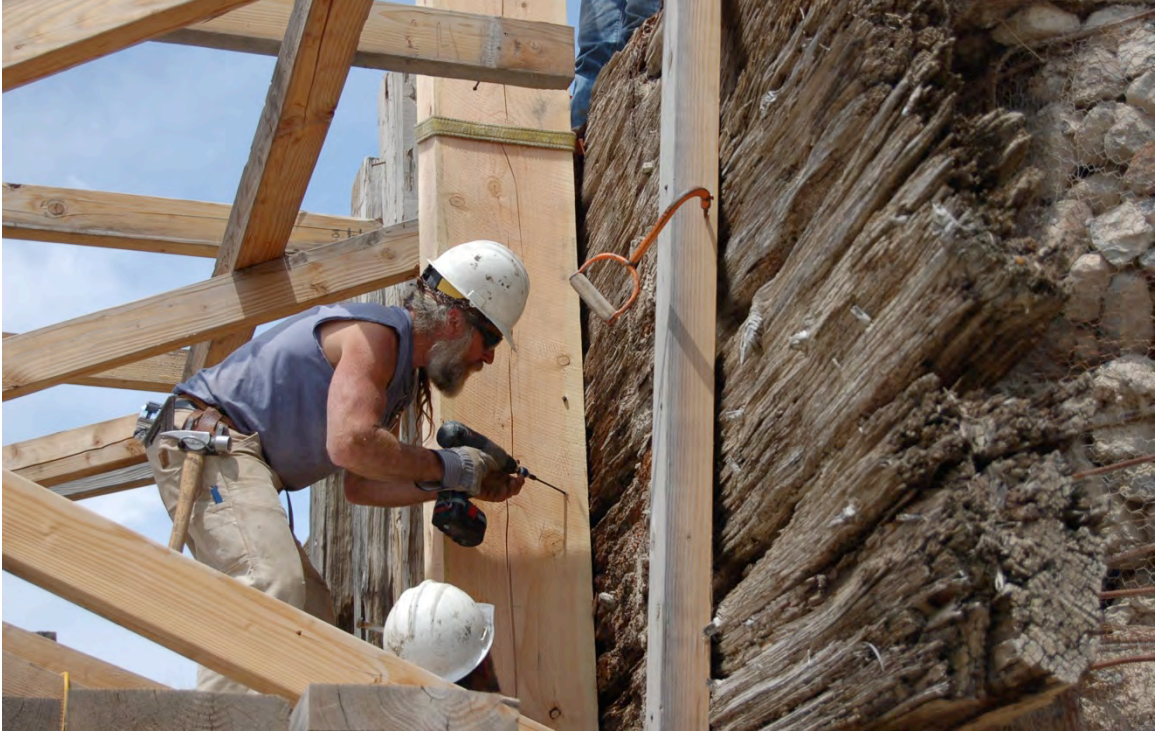
Figure 59: The replacement pile is tacked to the surrounding structure and then braced until a new pile cap is installed.

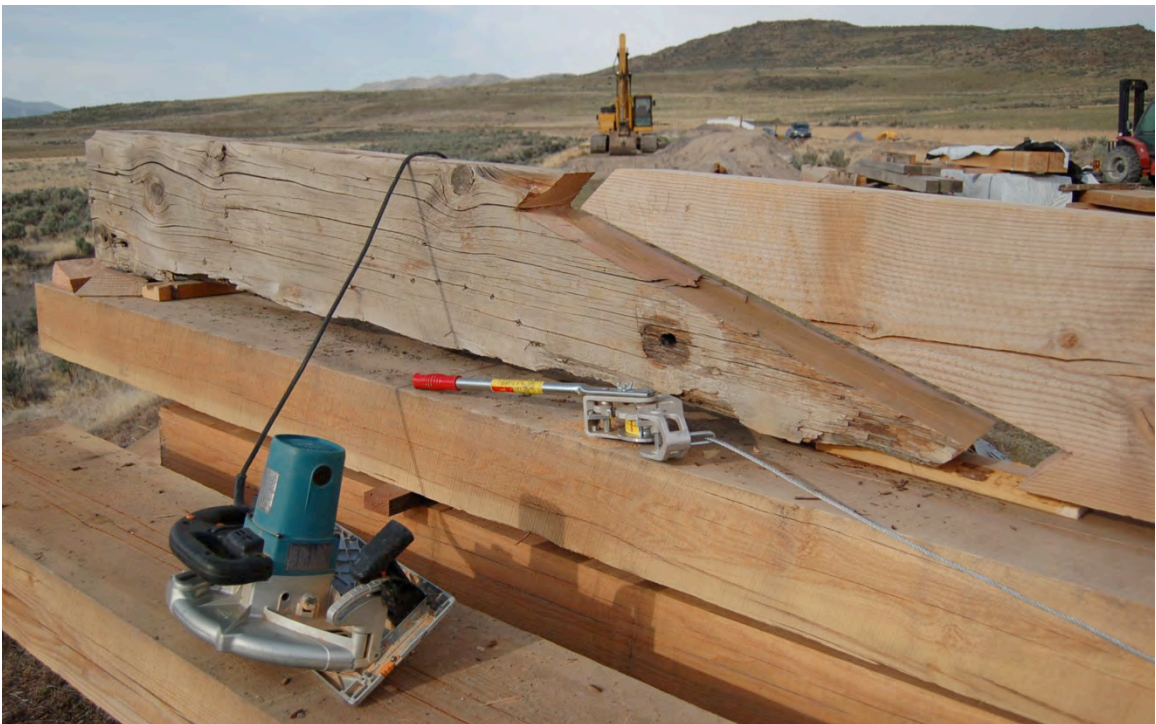
Figure 60: A scarf has been cut to repair one of the stringers of Trestle #1.

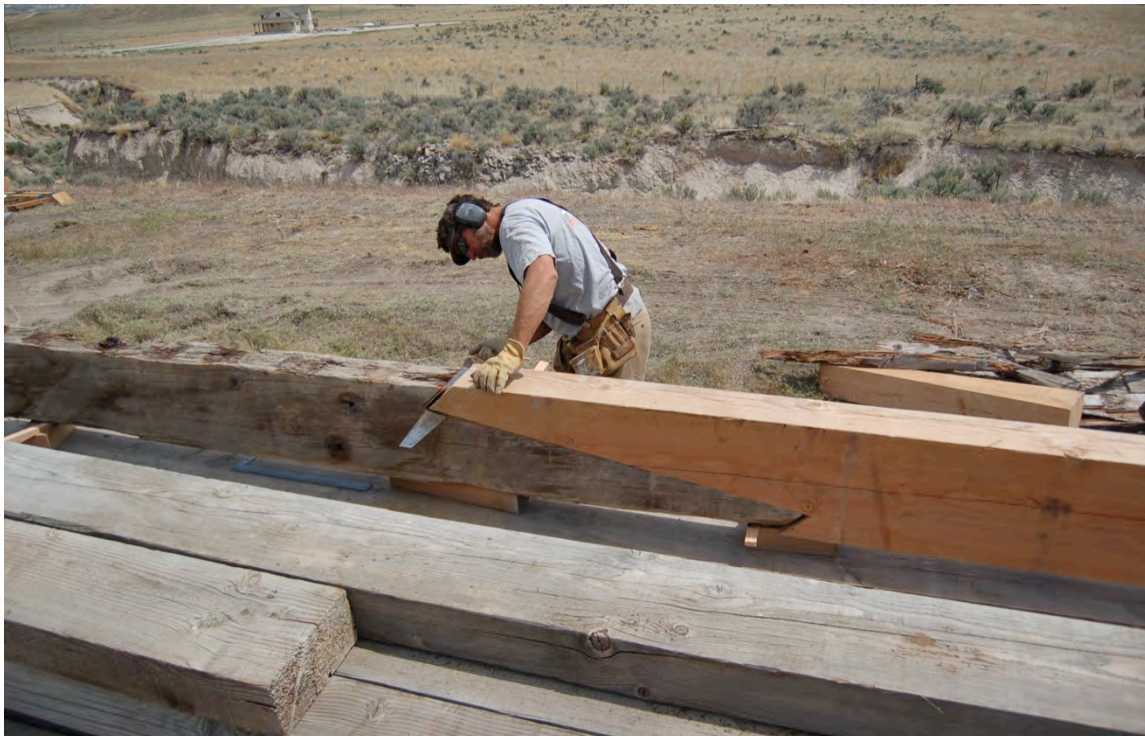
Figure 61: Adjusting the fit of a scarf joint.

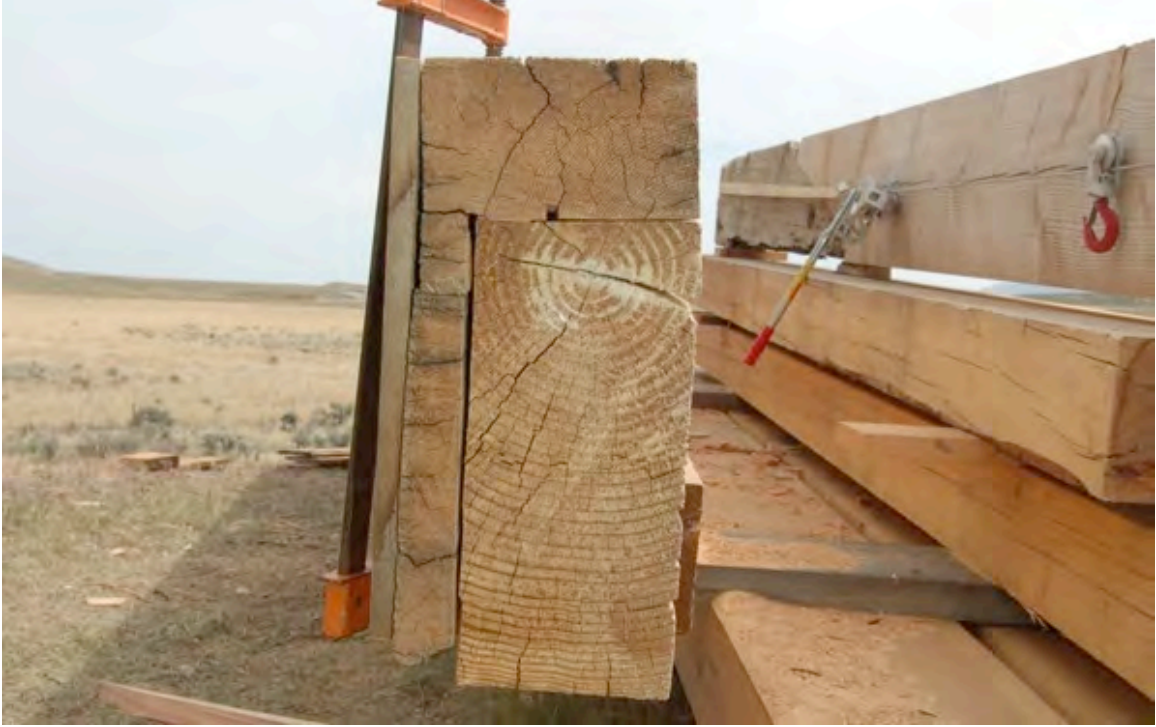
Figure 63: The repair for this stringer was a lap scarf that acts as a veneer over the new timber.

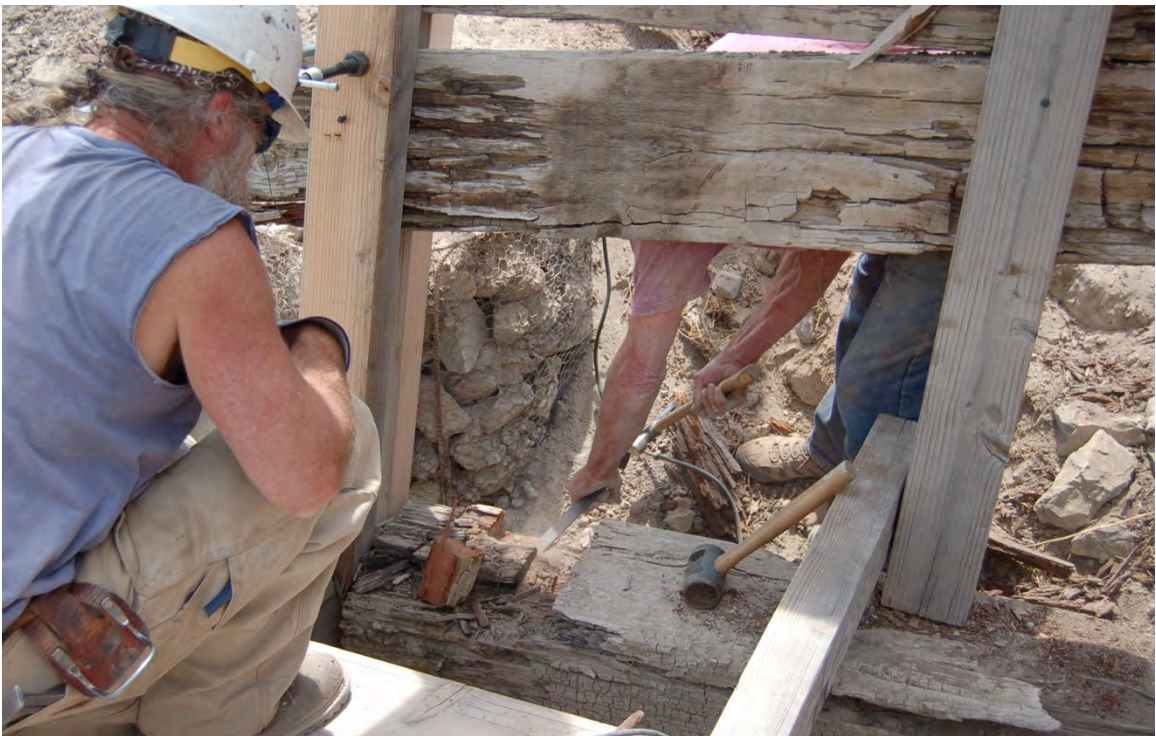
Figure 64: A section of the intermediary sill at the west bent was found to be soft as the result of decay. The section was removed with a reciprocating saw and later filled with an in-kind replacement block.

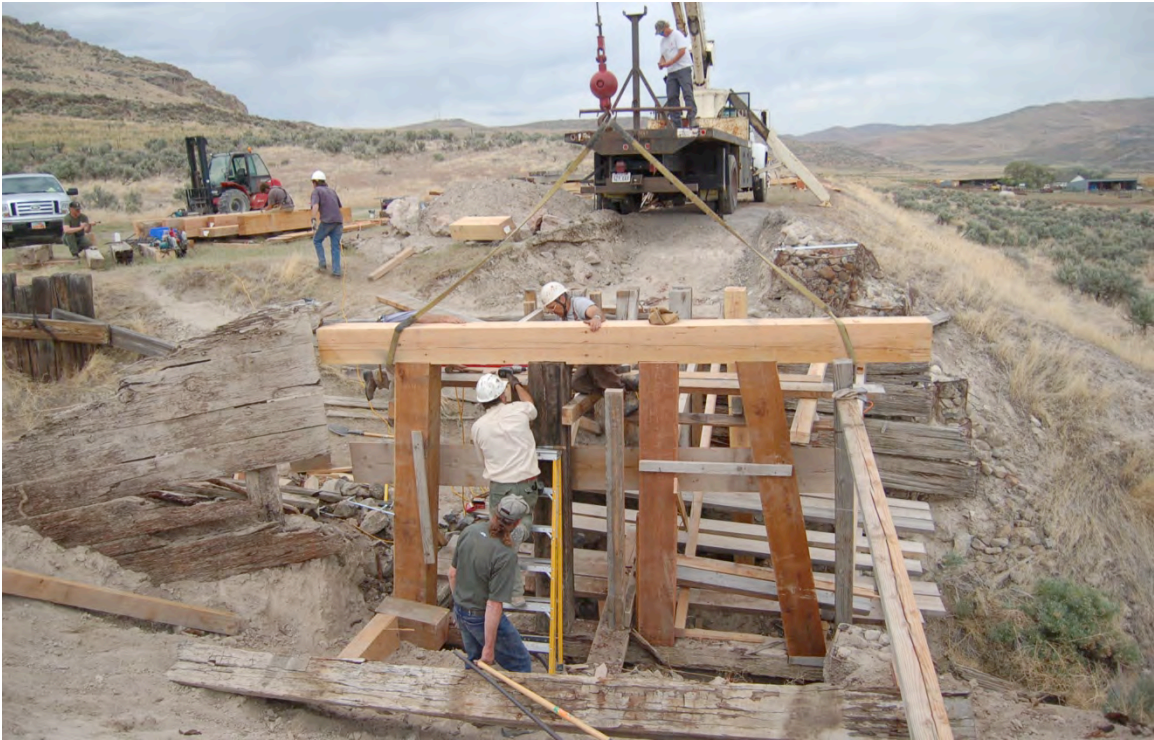
Figure 65: A replacement pile cap is positioned on the west bent.

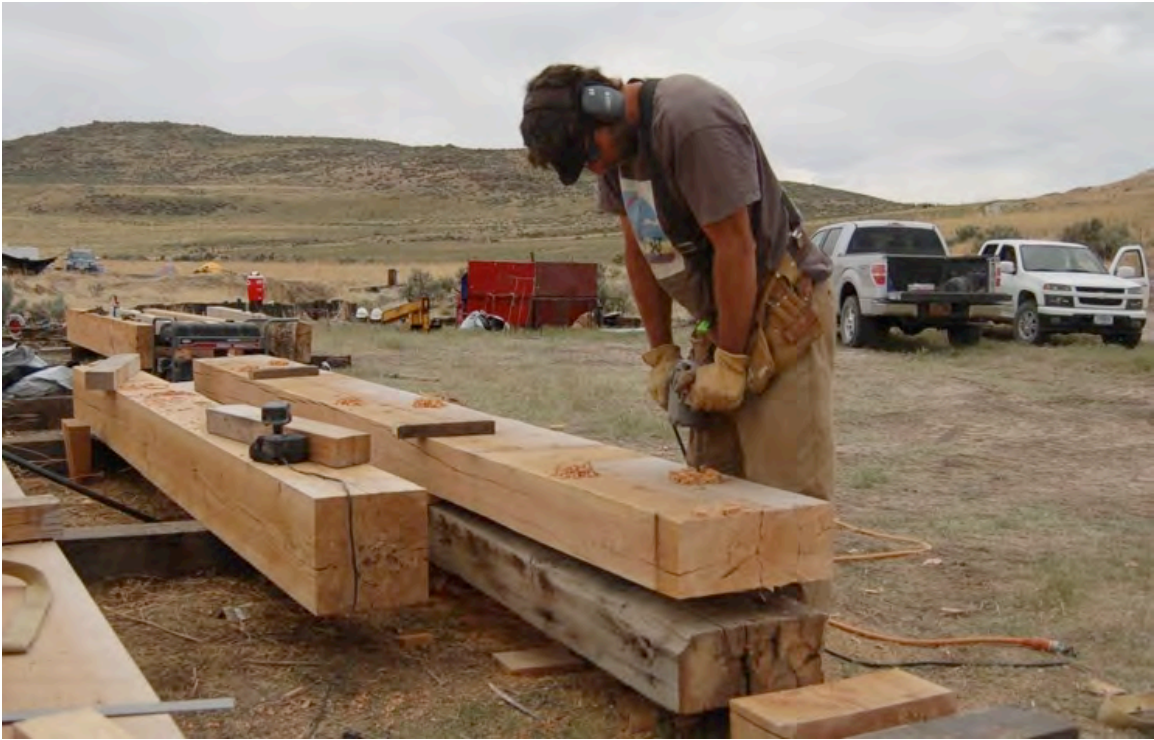
Figure 66: Drilling holes for the stringer hardware.

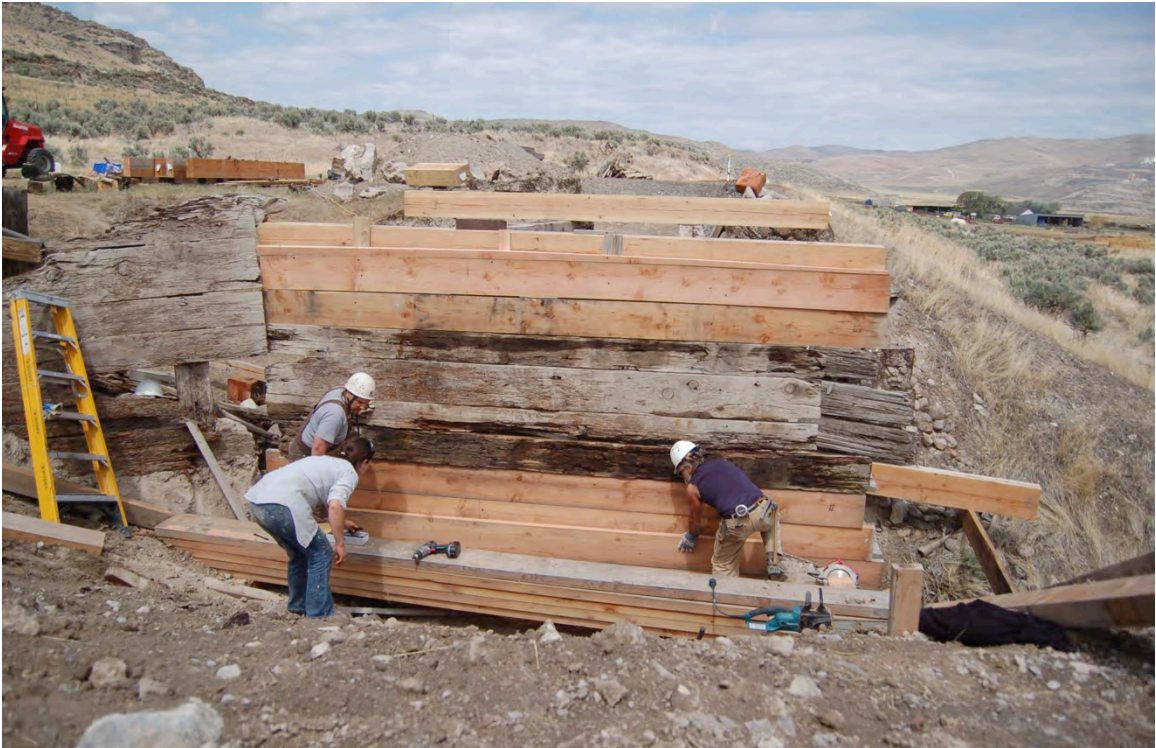
Figure 68: Starting the second layer of planking at the west bulkhead.

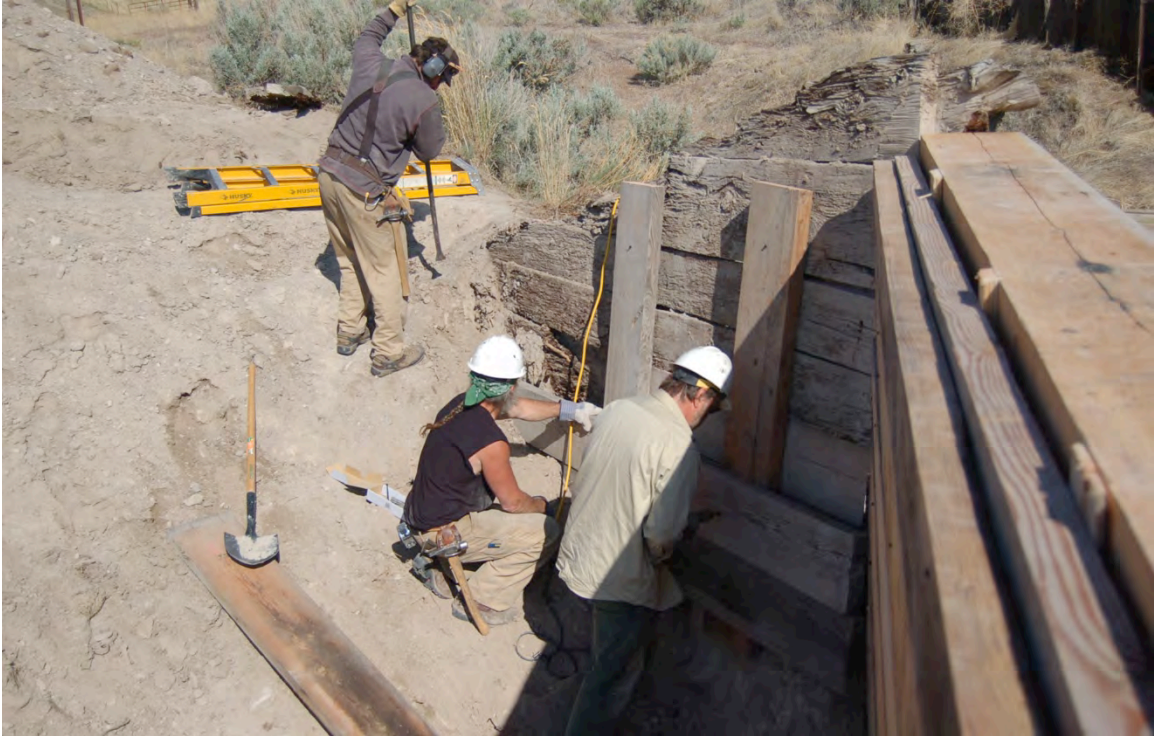
Figure 69: A second layer of planking was also applied to the back of the northwest wing wall to provide additional stability for the remaining original members.

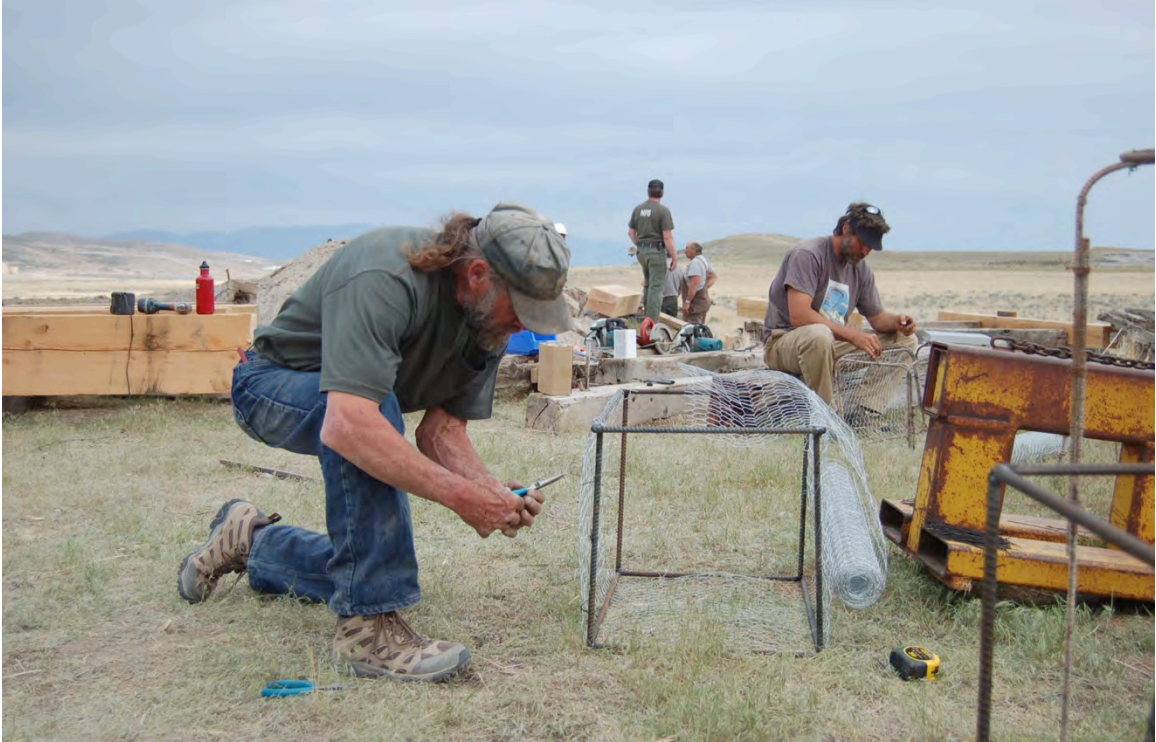
Figure 72: Replacement gabions were welded from #4 rebar and covered with two layers of wire netting.

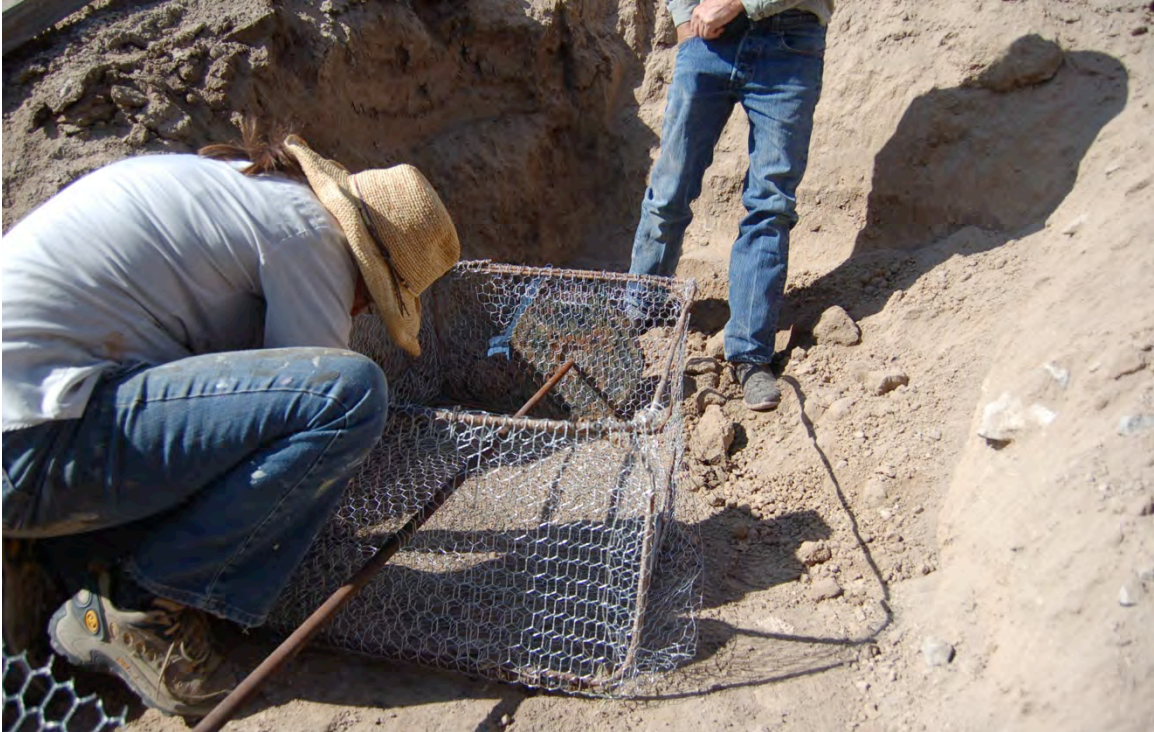
Figure 73: A deadman was installed behind the west bulkhead to add stability and to help prevent further twisting of the west bent.

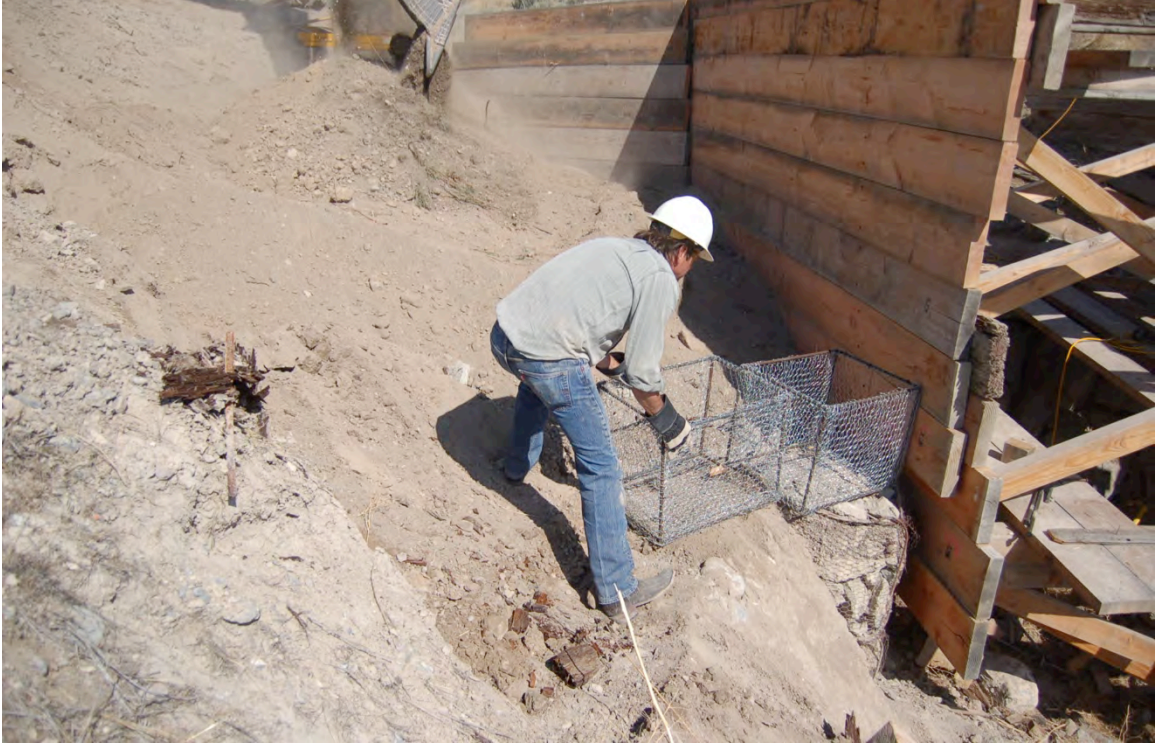
Figure 75: Gabions were replaced along the south slope behind the west bulkhead.

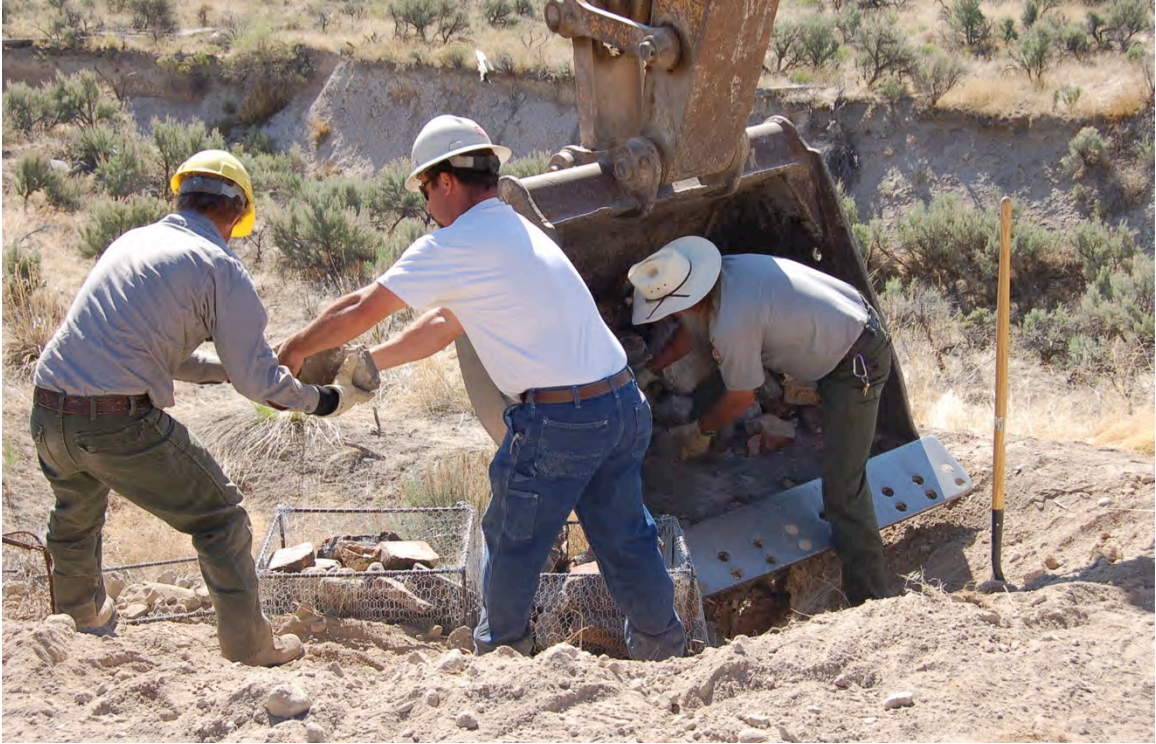
Figure 76: Filling the gabions with stone salvaged from the originals.

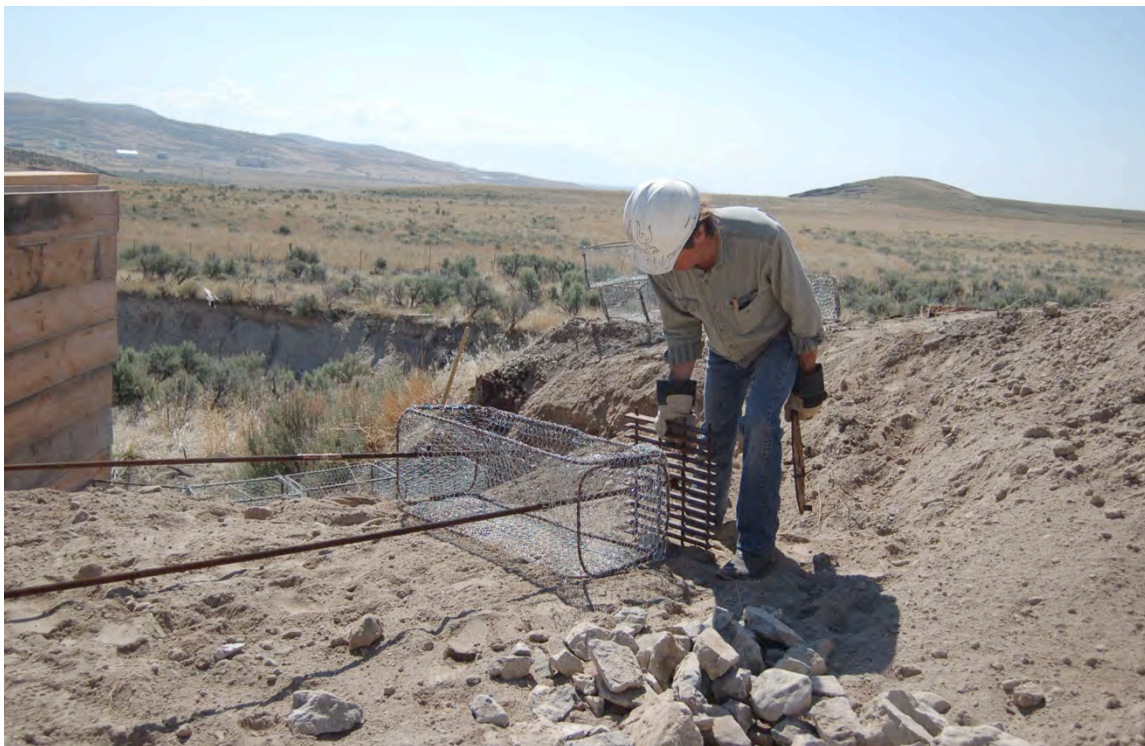
Figure 77: A second deadman was installed behind the northwest wing wall.

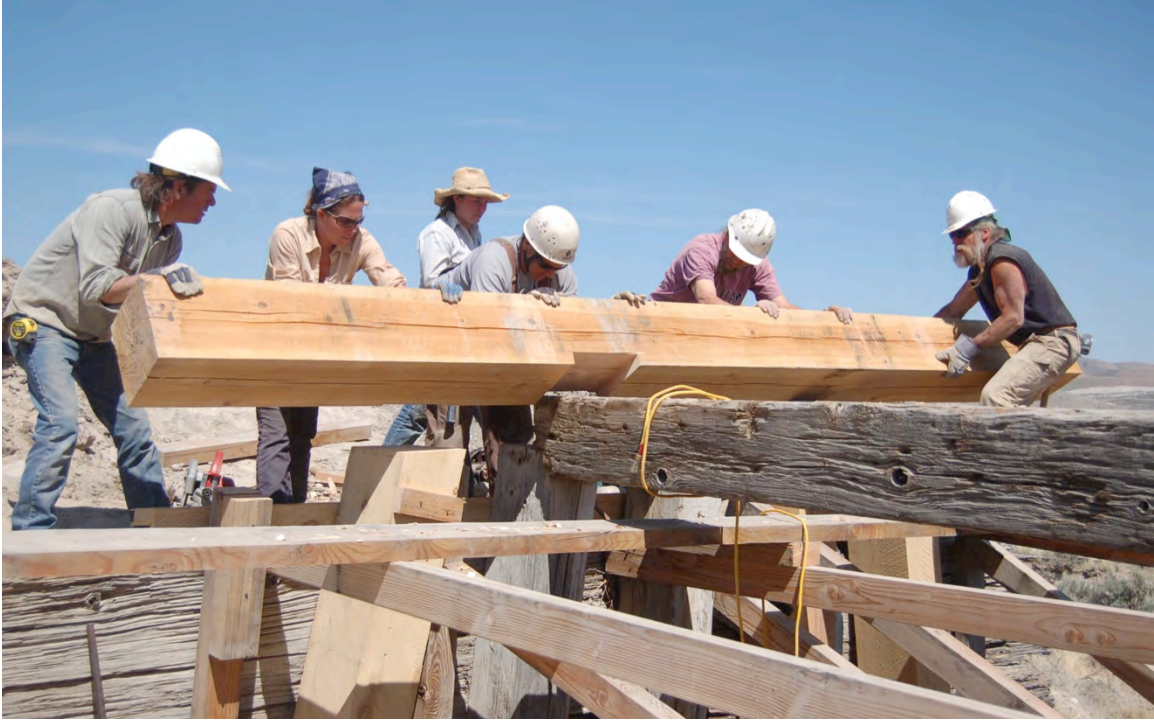
Figure 79: Replacement timbers were extremely heavy, often weighing several hundred pounds, and took several people to move them safely.

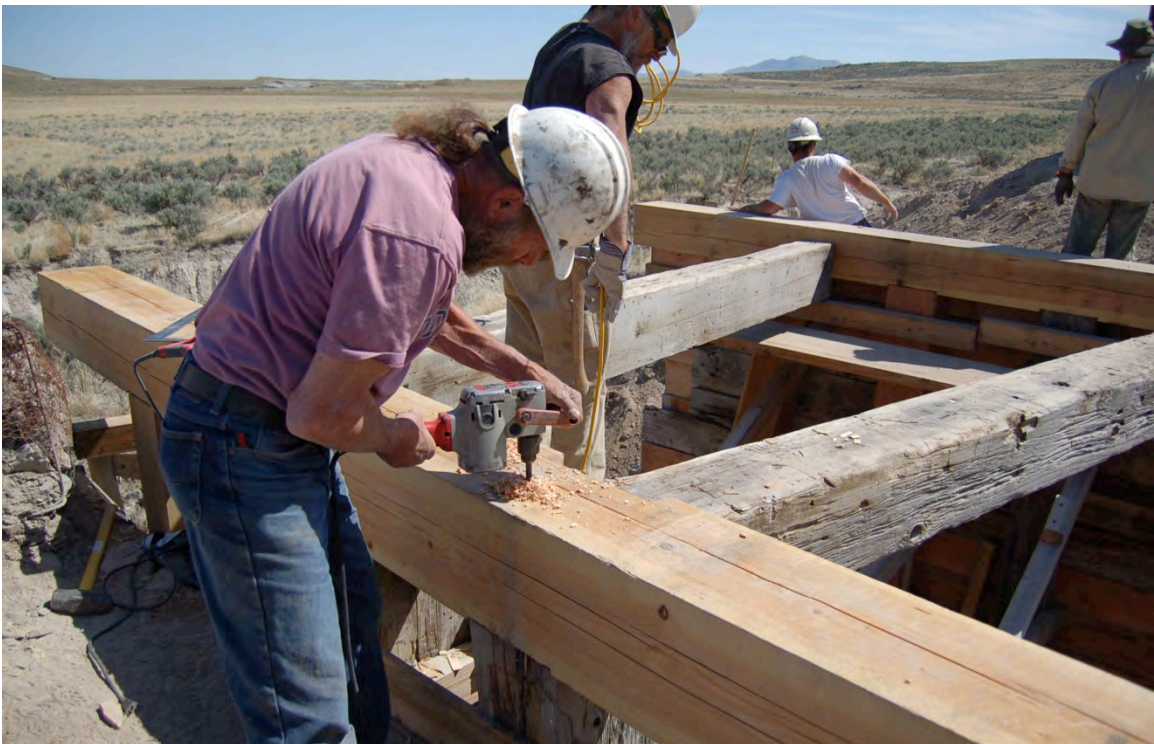
Figure 80: Drilling for hardware to secure the pile cap to the bent below.

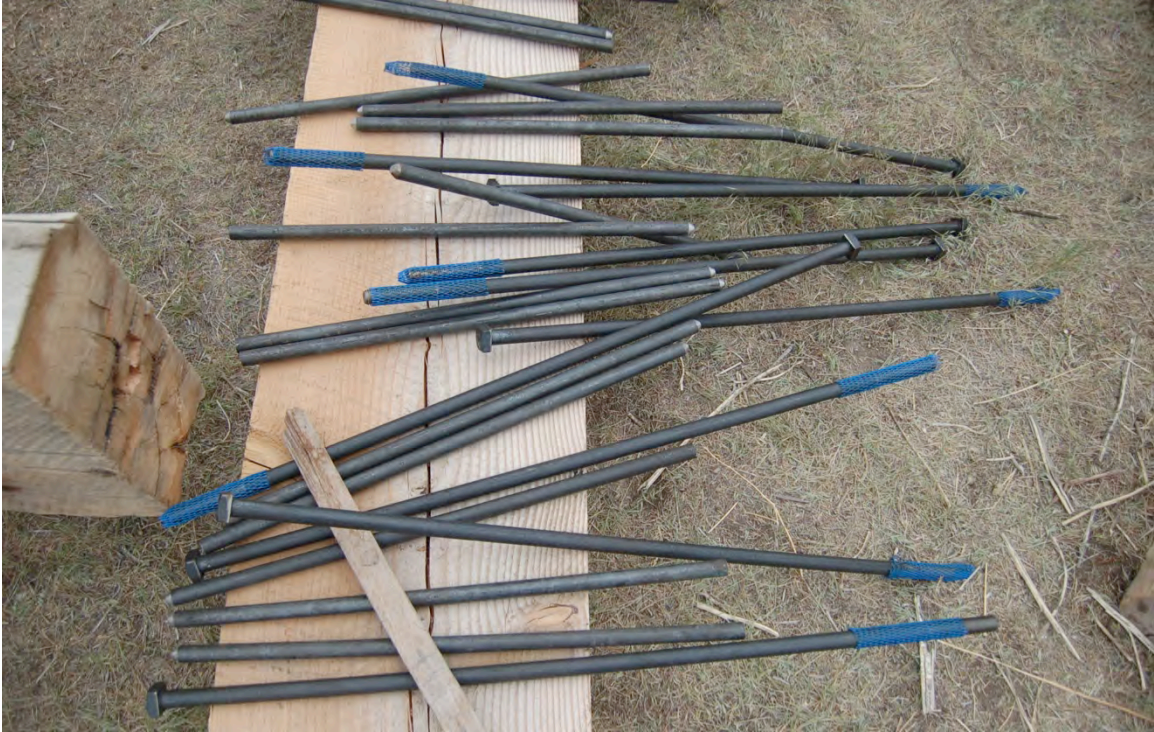
Figure 81: Drift pins were originally used to secure several of the trestle members to each other. These are replacements fashioned to duplicate the originals.

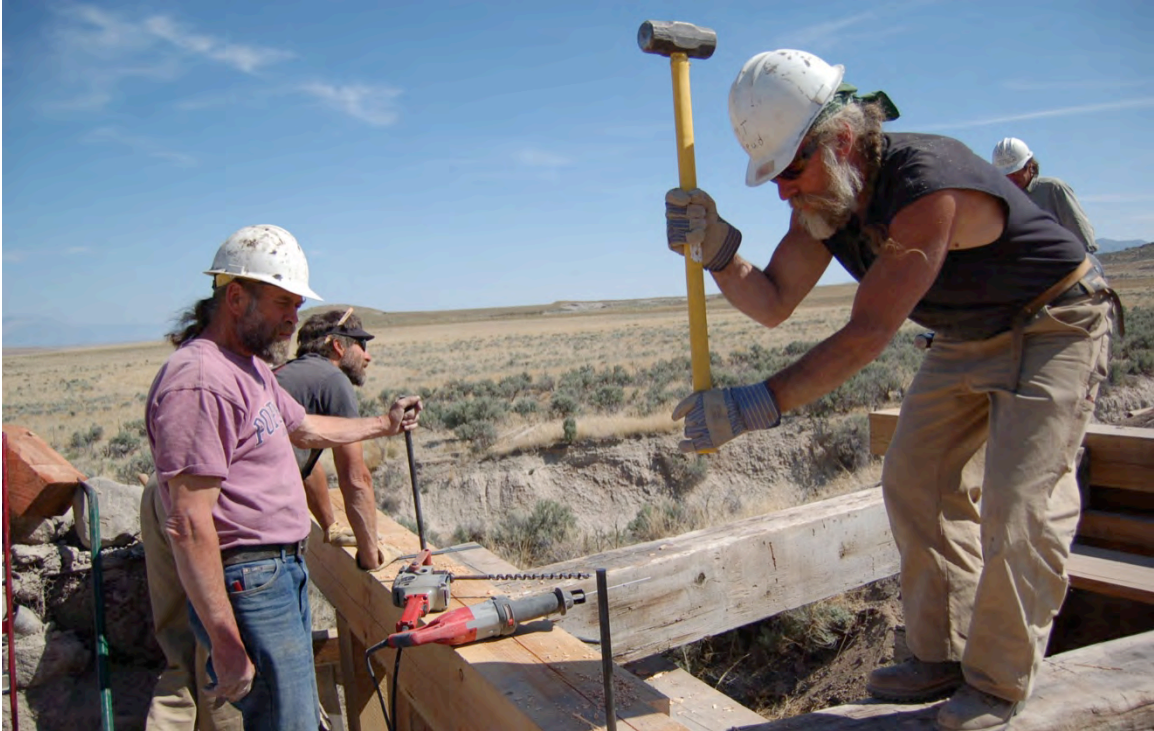
Figure 82: Driving drift pins through a pile cap into the piles below.

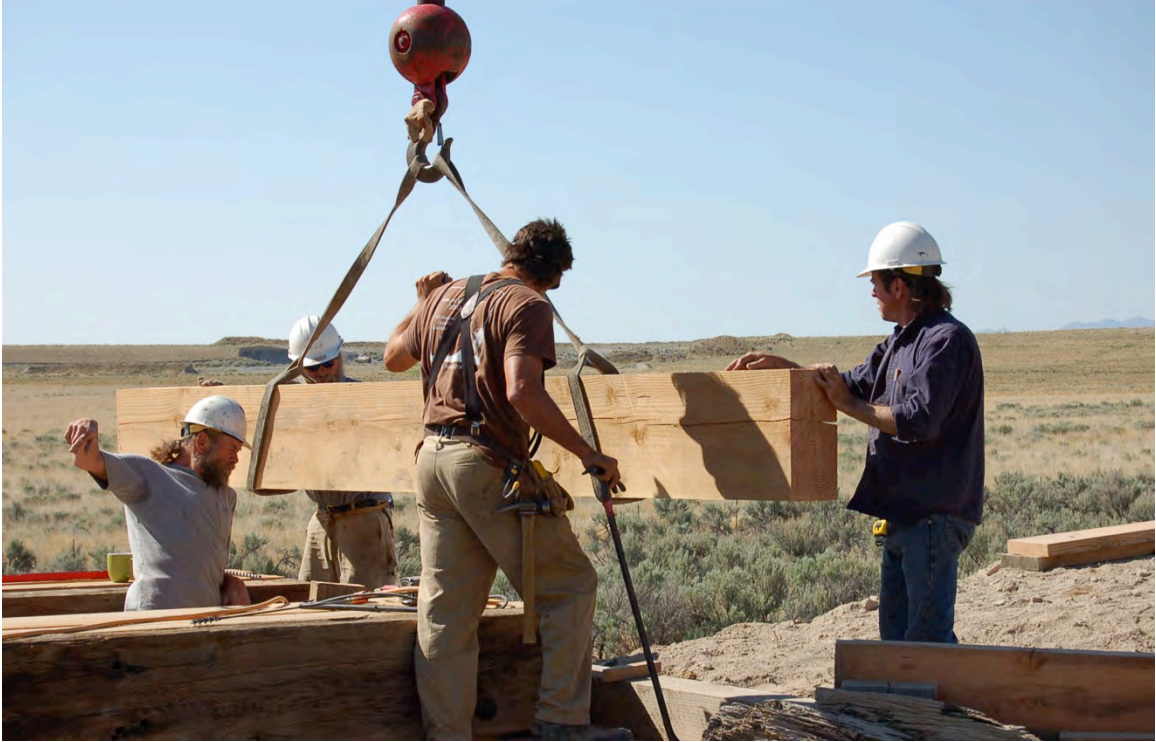
Figure 84: The last pieces to be installed are the top planks of the bulkheads.

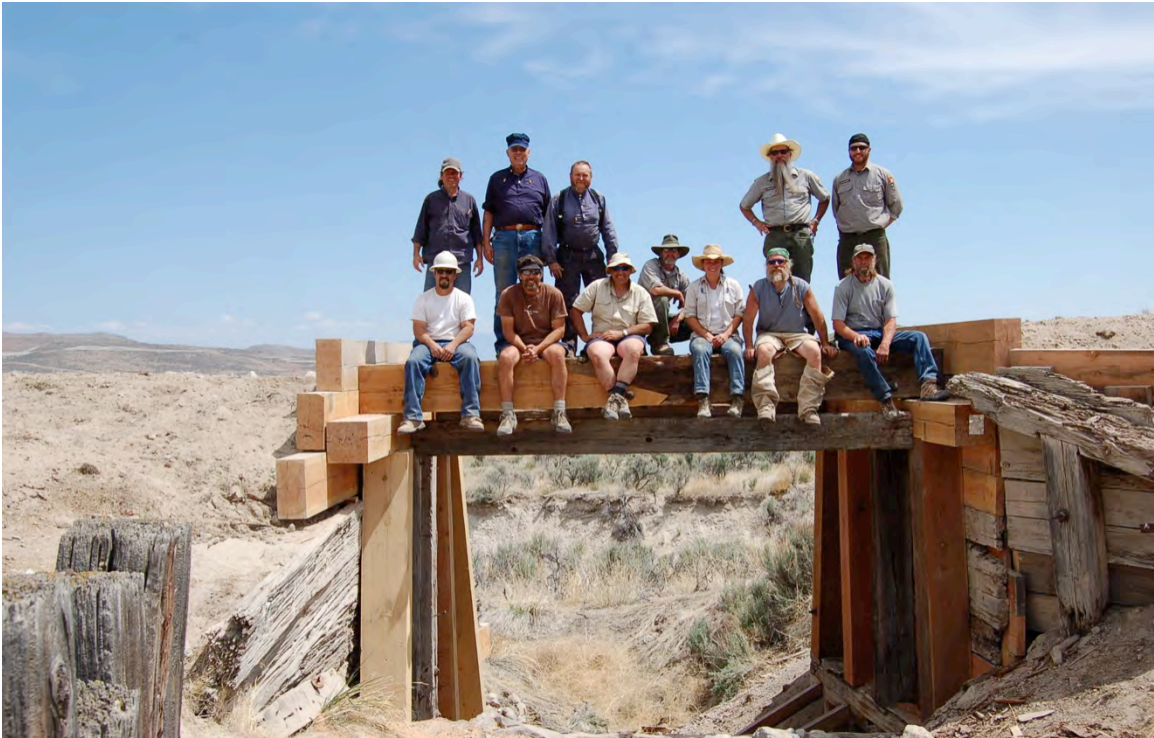
Figure 85: Trestle #1 after stabilization.

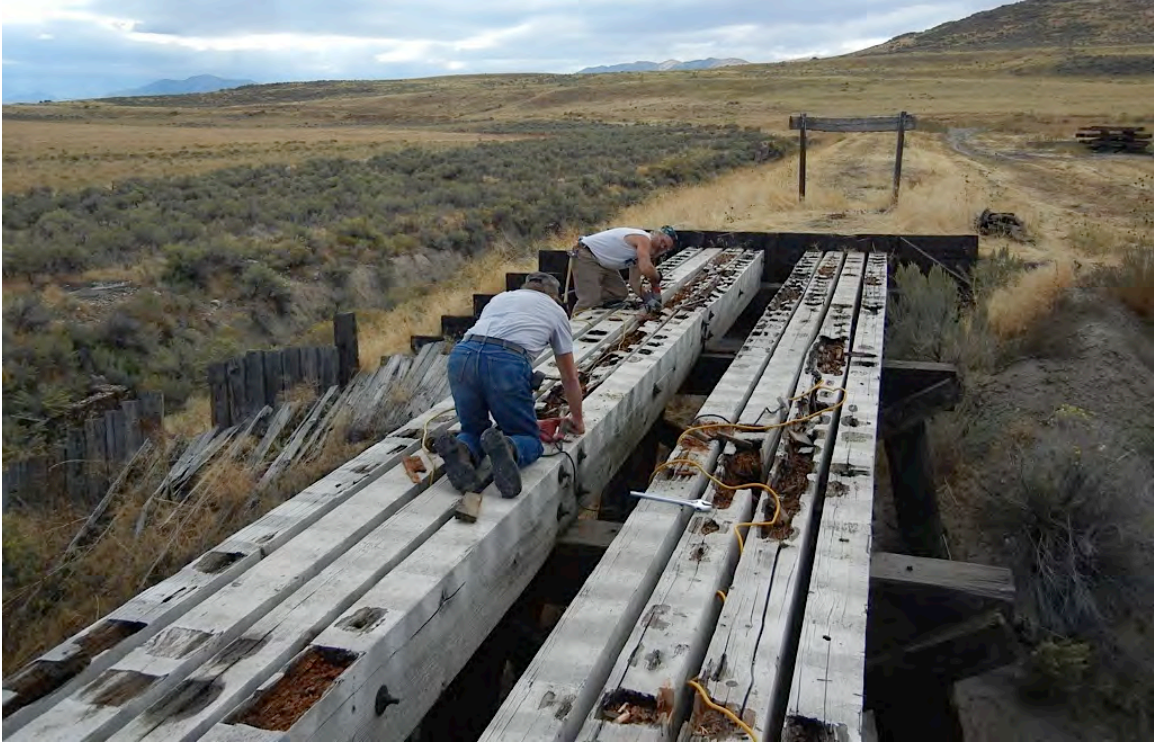
Figure 86: The stringers of Trestle #2 had significant pockets of decay along their length.

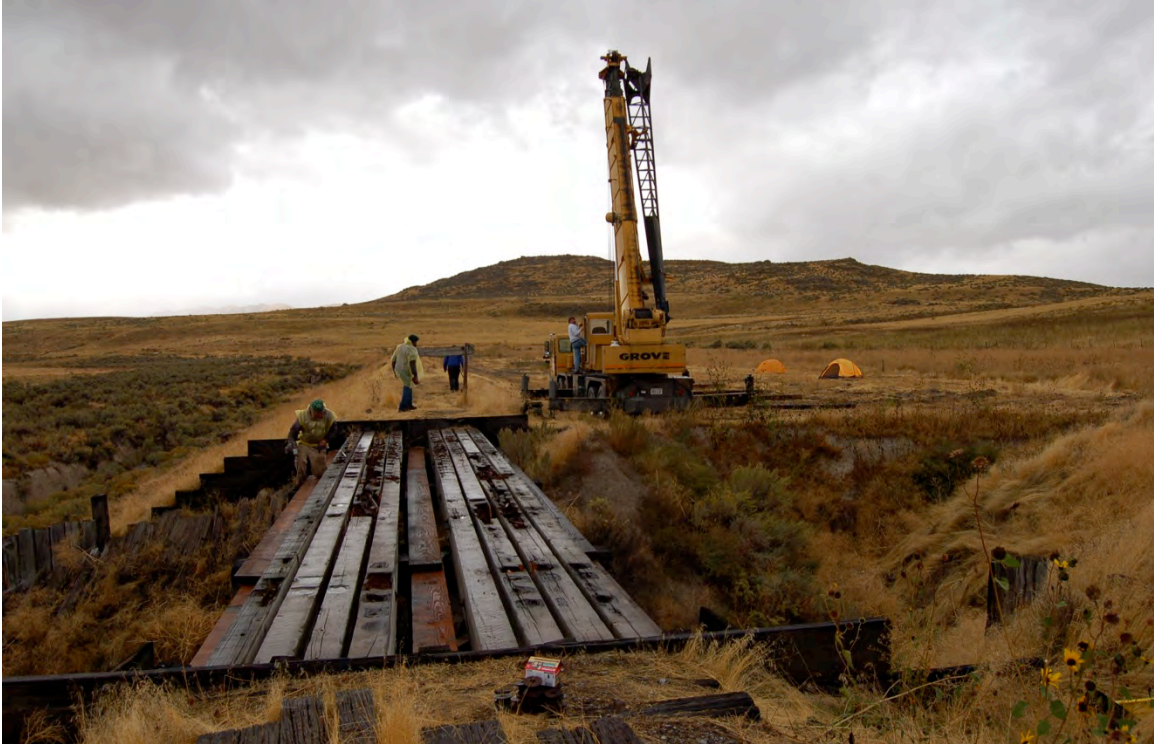
Figure 87: Planking was installed on either side and between the stringers assemblies to facilitate access and to act as guides for their eventual replacement.

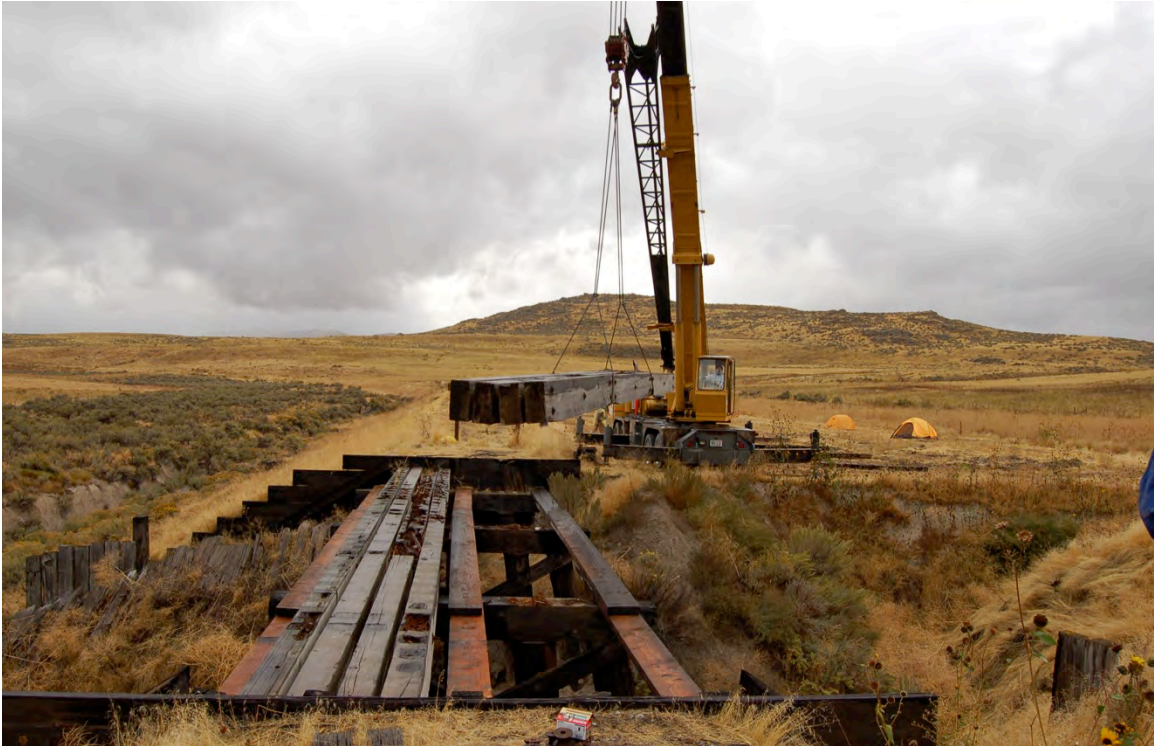
Figure 88: A crane was used to remove the assemblies from the trestle structure.

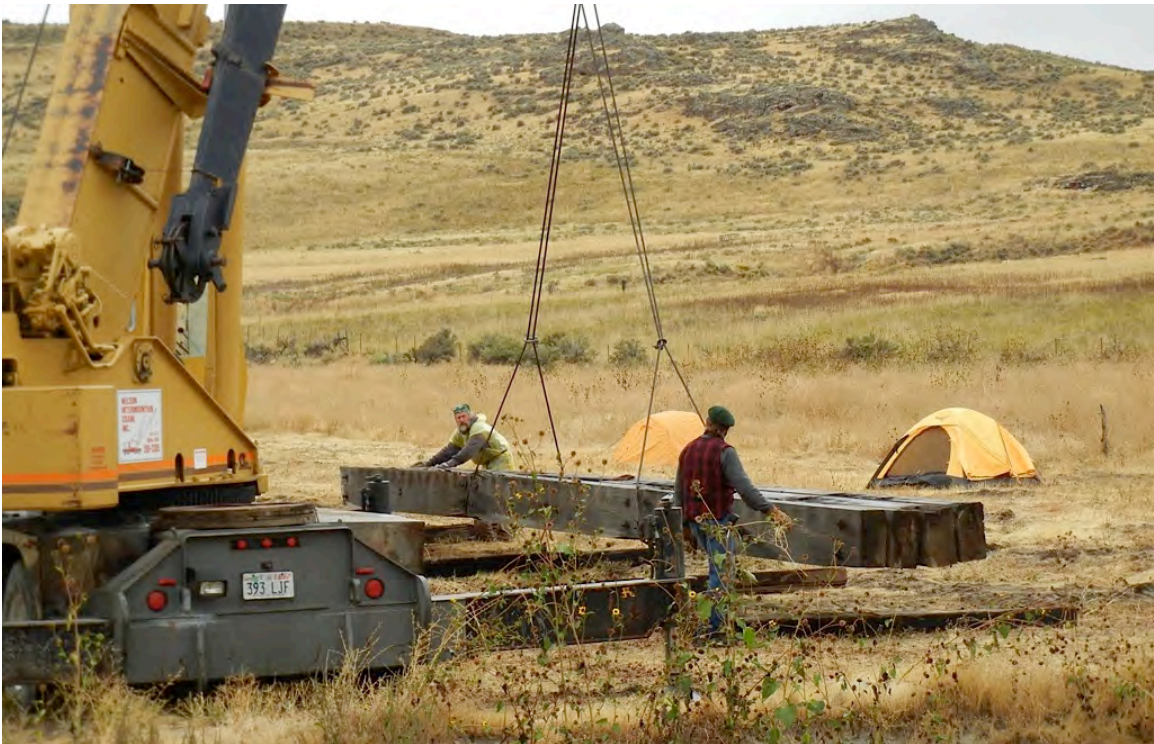
Figure 89: The assemblies were then set on timber beds for repair.

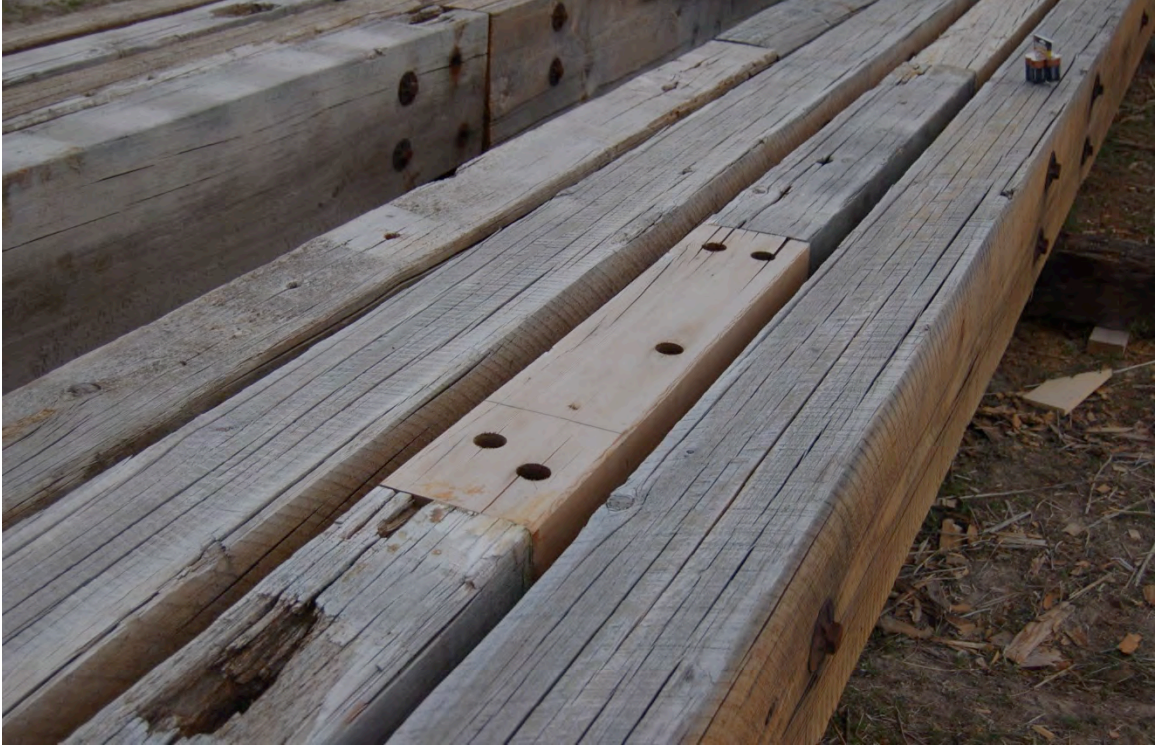
Figure 90: A dutchman repair.
