TREATMENT REPORT: PROMONTORY TRESTLE STABILIZATION AT GOLDEN SPIKE NATIONAL HISTORIC SITE

PREPARED FOR THE NATIONAL PARK SERVICE

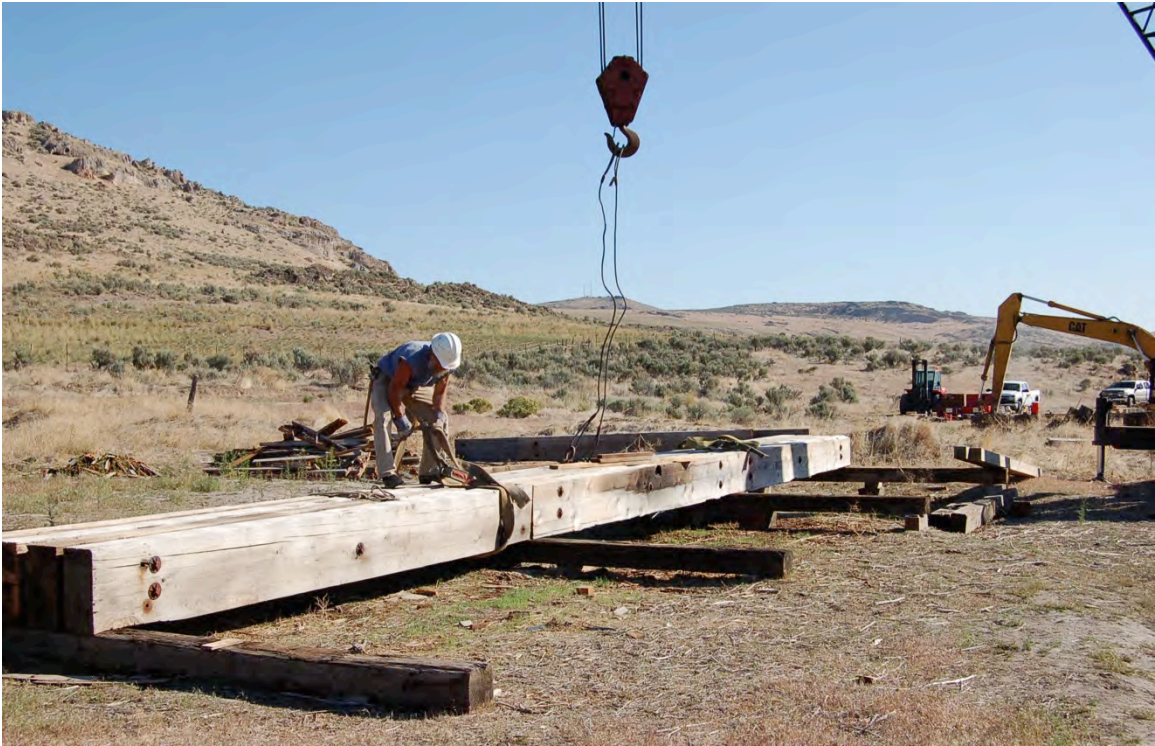
Figure 91: Rigging for the crane after repair and reassembly.

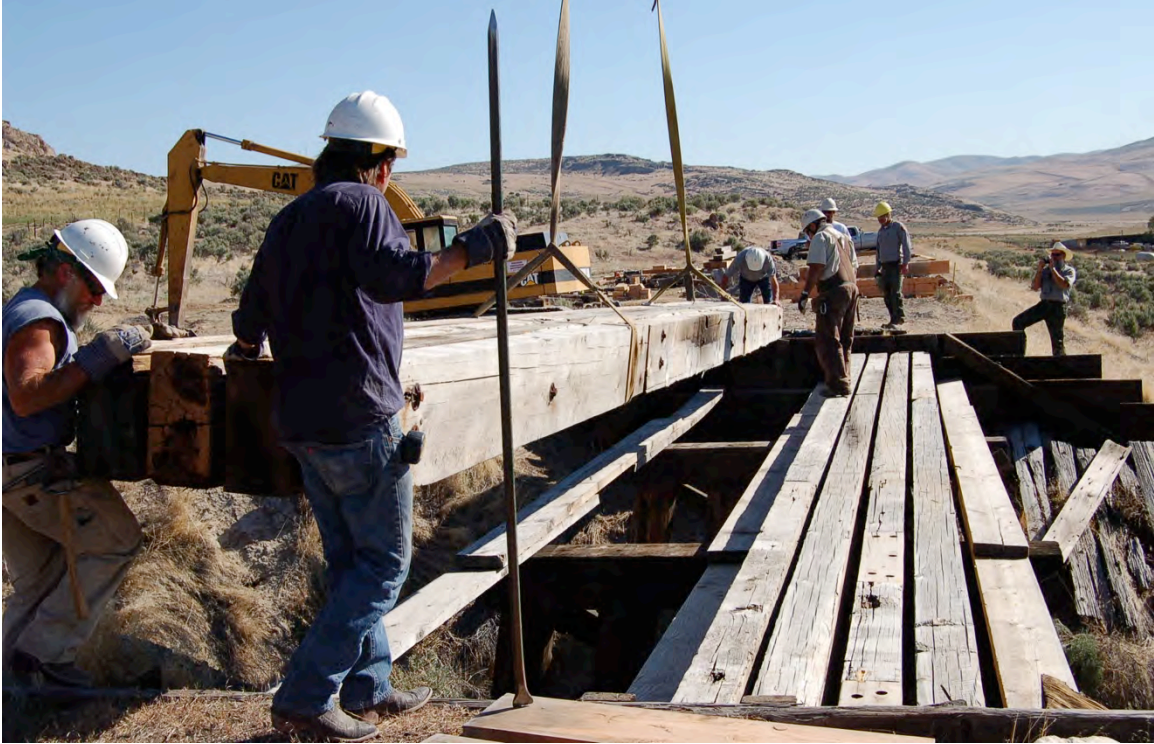
Figure 92: A stringer assembly is lowered back onto the trestle.

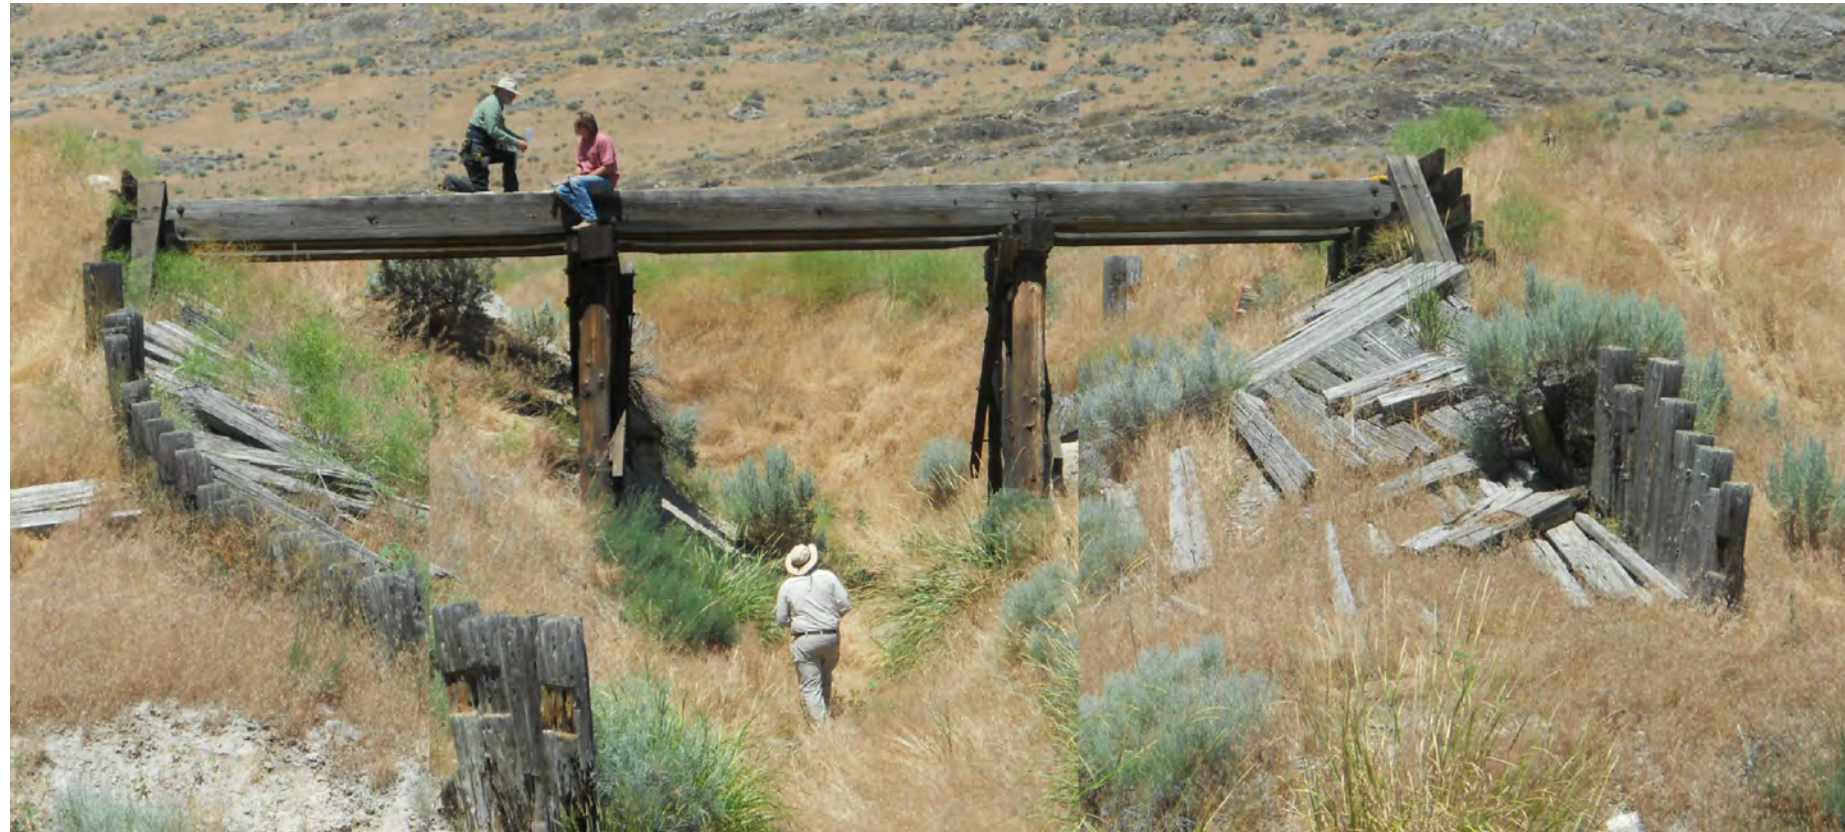
FIELDWORK AT PROMONTORY TRESTLE #2, GOLDEN SPIKE NATIONAL MONUMENT, 2011. PHOTO BY KERI STEVENSON.
